DEC-12-HVRTP-A-D

**VR14 and VR20
troubleshooting
procedures**

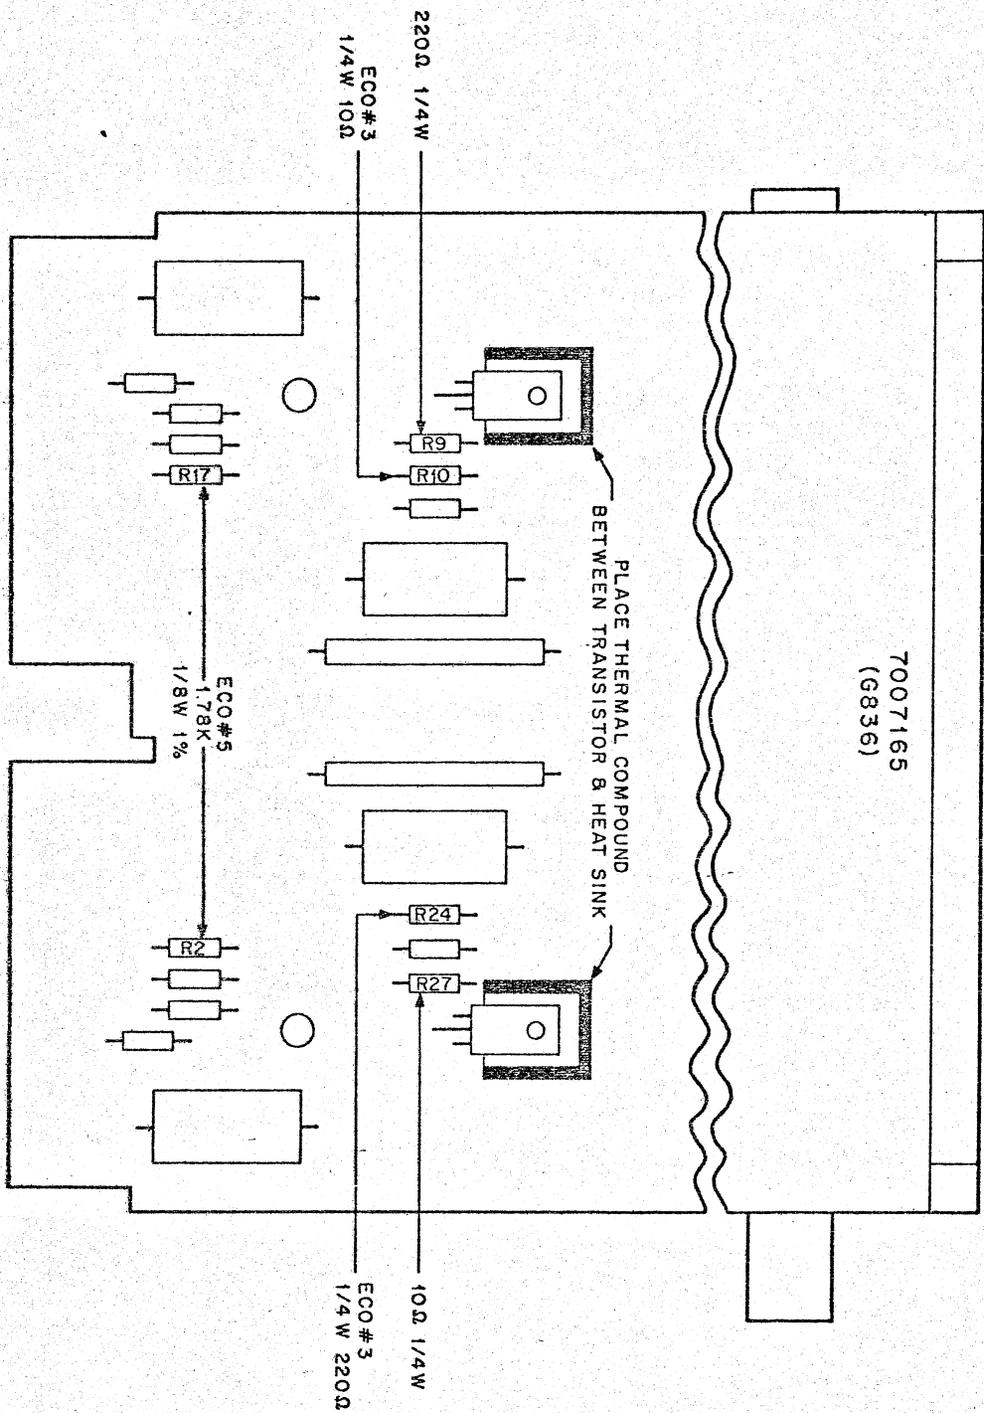
Figure 1 7007165 Power Regulator Assembly

4. Check the G836 regulator card on the 7007165 to ensure all ECOs have been incorporated (See Figure 1).
 - a. R9 and R24 should be 220Ω , not 1K.
 - b. R10 and R27 should be 10Ω , not 150Ω .
 - c. R2 and R17 should be 1.78K, 1% resistor, not 1.62K, 1%. This lowers the +24V to +22V.

5. If power supply voltages drift or wander, change Q2 (2N4920), or Q4 (2N4923), E1 (709), and E2 (709) or obtain a new 7007165 regulator. Make certain that the board (G836) in the new regulator is *revision D* or higher. Reworked revision B boards with a decal are acceptable. Make certain that the A225 boards have ECOs 2, 4, 5, and 6 incorporated (Figure 2).

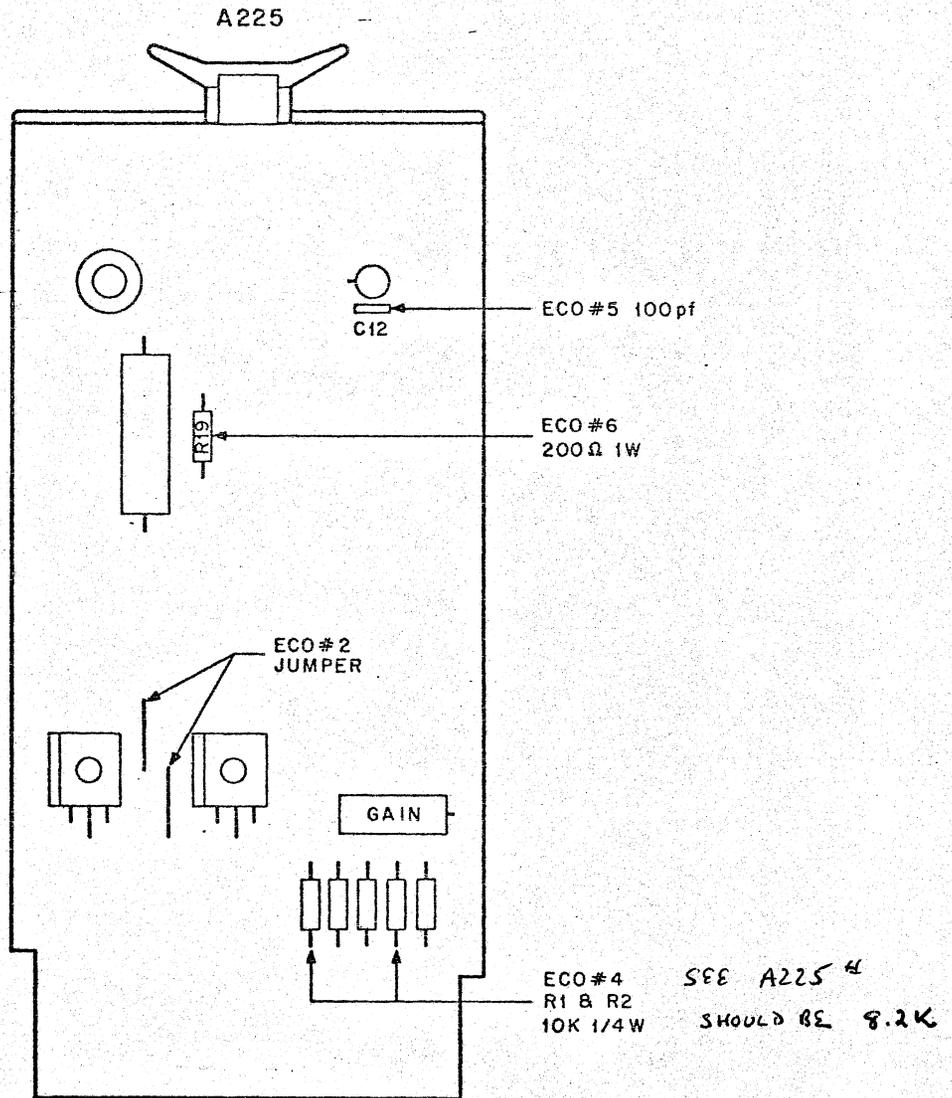
Figure 2 A225 D/A Converter

- ECO #2 R29 and R30 (22Ω) replaced by wires (Reduces runaway)
- ECO #4 R1 and R2 are 10K 1/4W. (Reduces gain sensitivity)
- ECO #5 C12 is 100 pf. (Prevents internal oscillations)
- ECO #6 R19 is 200Ω 1W. (Prevents internal latchup)

Make certain that resistor R19 on the A225 is 200Ω rather than 270Ω (see Figure 2). The resistor was changed by ECO #A225-6 to prevent a latch-up problem.

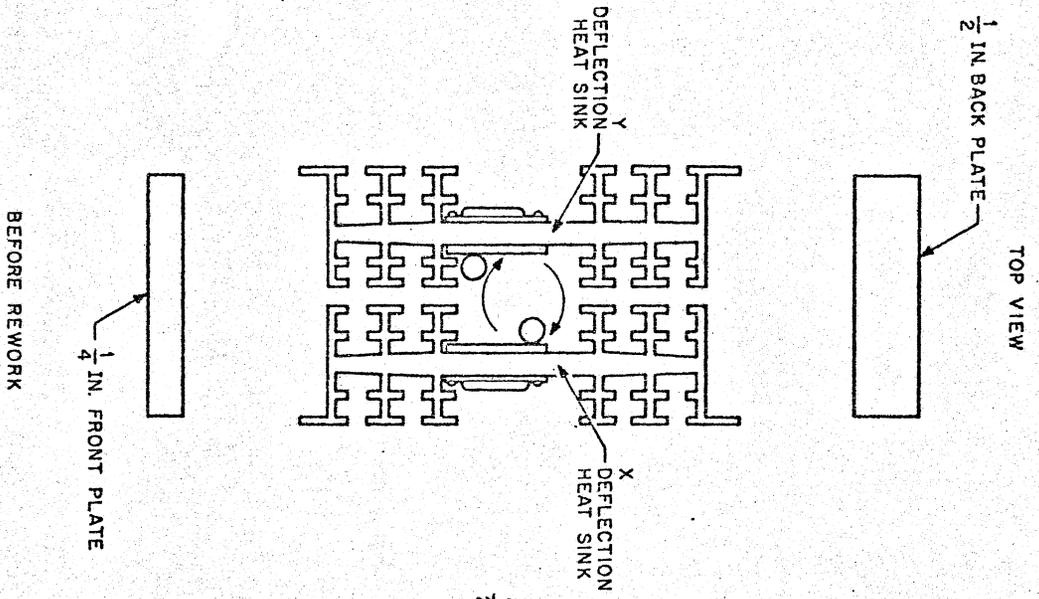
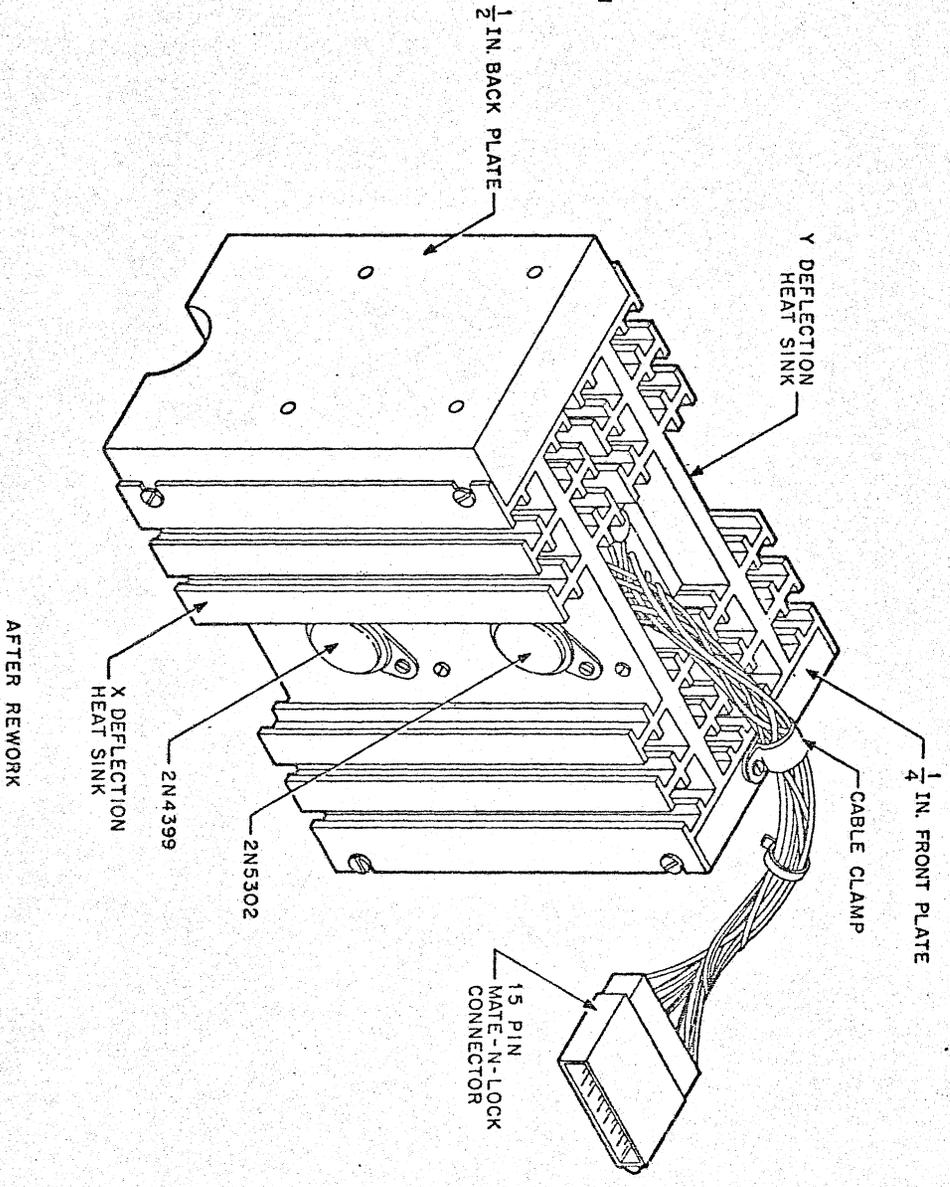
Figure 3 Deflection Heat Sink

6. In order to increase heat dissipation for the power transistors, ECO #VR14-15 must be installed. This ECO consists of physically interchanging the inside section (X) of the deflection heat sink assembly with the outside section (Y). This is done because the outside section receives better air flow. Since X generates more heat than Y, X requires more cooling air.

The interchange is accomplished by unscrewing the end plates of the heat sink assembly, exchanging the heat sinks so that X heat sink is on the outside, and then replacing the end plates.

Before reassembly, remove the thermal cutout on the X heat sink and replace it with a 6-32 screw to hold the terminals on the inside. Place a jumper plug across the thermal cutout leads because the cutout is no longer used and the line circuit must be completed.

1. Remove deflection heat sink assembly from the VR14.
2. Remove 6-32 X 3/8 screw that secures cable clamp to 1/4-inch front plate.
3. Remove eight 6-32 X 1/4 screws that secure X and Y heat sinks to front and back plates.

4. Remove thermal cutout from X deflection heat sink and place a 6-32 X 1/2 pan head screw in the hole.
5. Place 1/2-inch back plate on a flat surface with the two mounting screws (used for securing heat sink) facing up and half-circle cutout facing the bottom.

6. Secure the X deflection heat sink (identified by grey wire on transistor collectors) to the 1/2-inch back plate, using two 6-32 X 1/4 screws. Make certain the 2N4399 transistor is on the bottom.

7. Place 1/4-inch mounting block on other side of the X deflection heat sink with the cable clamp screw hole facing the top. Secure with two 6-32 X 1/4 screws.

8. Secure the Y deflection heat sink (identified by violet wire on transistor collectors) to the opposite side of the assembly, ensuring that the 2N4399 is on the bottom.

9. Secure the cables from X and Y deflection heat sinks to the top of the 1/4-inch front plate with cable clamp and 6-32 X 3/8 screws.
10. To complete the AC line circuit, place a jumper plug (7007006-3) in the 2-pin connector that was connected to the plug for the thermal cutout.

11. Replace deflection heat sink assembly in the VR14.

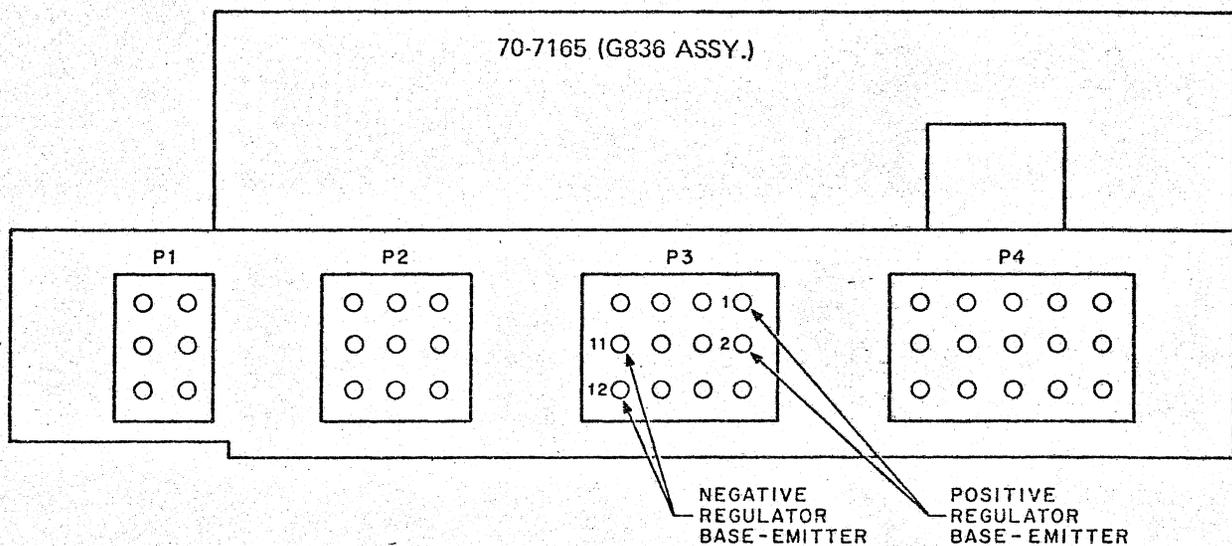
Figure 4 Base-Emitter Voltage Drop, Test Point Location

12. Refer to Figure 4. Measure the base-emitter voltage drop in the power supply heat sink assembly. Because only the positive supply is being used, it should indicate full drop, 1.2V, while the negative supply should indicate only standby drop 0.5V. If the positive supply measurement indicates 2.4V base-to-emitter drop, then one of the 2N4399 transistors is open. Replace both 2N4399 transistors!

13. While measuring the appropriate yoke return, adjust the position potentiometers on the X and Y deflection boards for -2.5V and -2.0V deflection (upper right corner deflection). Then, again measure the base-emitter voltage drop for the negative supply. It should then be 1.2V and the base-emitter drop for the positive supply should be 0.5V. Return the position potentiometers to their original values.
