<b>digital</b>	<b>FIELD SERVICE TECHNICAL MANUAL</b>				Option or Designator
	12 Bit <input checked="" type="checkbox"/>	16 Bit <input checked="" type="checkbox"/>	18 Bit <input type="checkbox"/>	36 Bit <input type="checkbox"/>	AD01

Title AD01 MULTIPLEXER F.E.T. Leakage				Tech Tip Number AD01-TT-1	
All Processor Applicability			Author R. Adams	Rev 0	Cross Reference
8's	11's		Approval J. Blundell	Date 12/07/72

Title AD01 Source Impedance Problems				Tech Tip Number AD01-TT-2	
All Processor Applicability			Author A. Thompson	Rev 0	Cross Reference
8's	11's		Approval G. Chaisson	Date 12/08/72

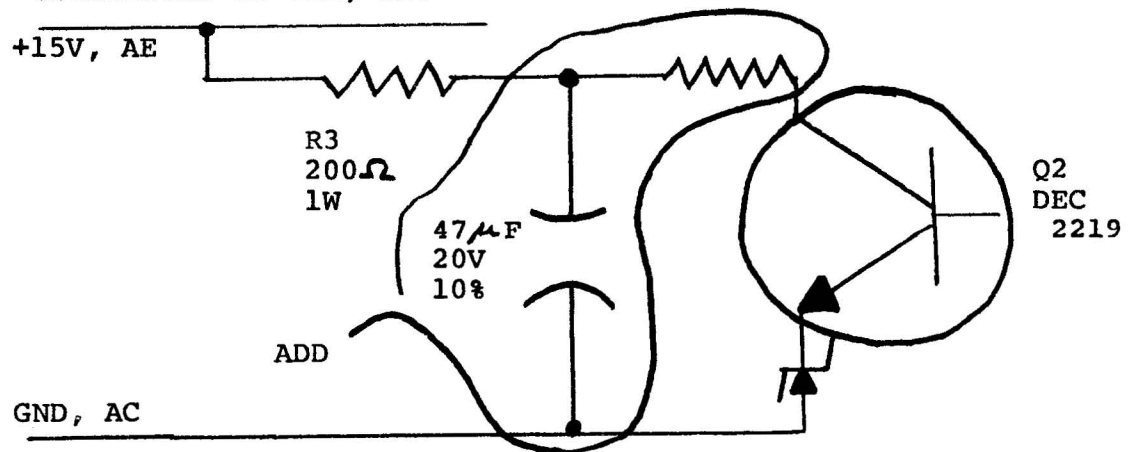
**Problem:** AD01A A/D converters that have AH04 and AH05 (Sample/Hold and Sign bit bipolar) options installed have been exhibiting a power supply problem. The problem is seen when more than three (3) A124 modules (12 channels) are installed. The symptoms are that the positive 15 volt drops to 8 - 10 volts. This drop in the +15 volt line also causes the +5 to drop and the -15 likewise.

**Cause:** The cause of this problem is the use of the Deltron P/N 12-03185-3 Power Supply, which during power up, becomes overloaded and due to its inherent characteristics cannot recover from the overload condition.

**Correction:** An ECO A708-0003 adds a 47 ufd cap. 20V 10% and a 97Ω ½W resistor from collector of Q2 a DEC 2219 transistor to GND, AC.

**Correction:** This problem is also corrected with the installation of a Power Mate power supply P/N 12-03185-3.

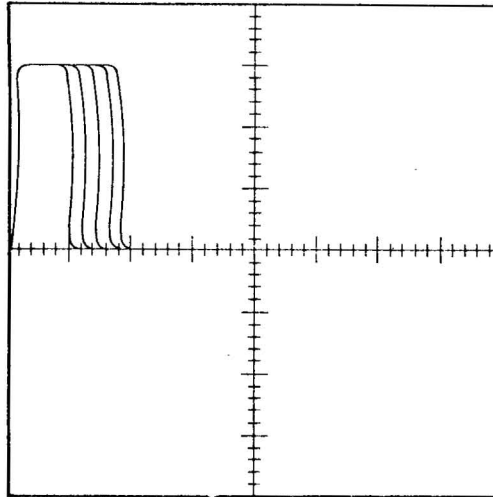
NOTE: A RAGGED TRAILING EDGE  
IS CAUSED BY TAPE BOUNCE
