Title	CC	ONVE	RTI	NG .	ASR-	-33 TO	PDP-8/E		Tech Tip Number	LT33-TT-1
All		Proc	essoi	App	olicab	ility	Author Sweeney/Quinn	Rev	В	Cross Reference
x							Approvai F. Purcell	Date 7/3	1/73

FIELD SERVICE TECHNICAL MANUAL

LT33

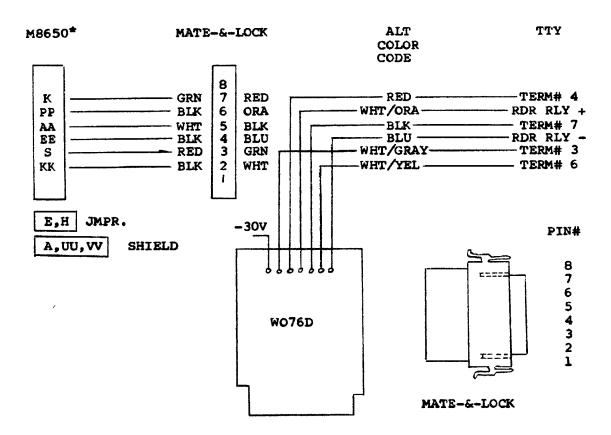
* If the Teletype Control Module is an M865, the split lugs are to be connected to the TTY as follows:

```
SPLIT LUG#4 = RDR RLY - #3 = TERM #3 
#7 = TERM #4 
#5 = TERM #7 
#6 = RDR RLY + 
#2 = TERM #6
```

The above chart has been designed to reduce the amount of time you would normally spend cross-referencing several different sets of prints. It is highly recommended that, before applying power to the reconfigured system, you double-check all wiring for correctness. Failure to do so could result in damage to the Teletype Control Module and/or the Teletype.

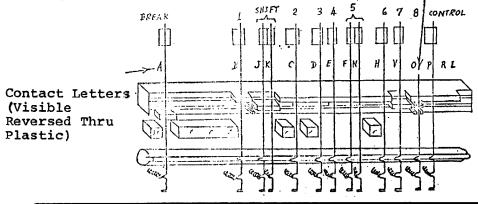
Right Side View Of Keyboard Contact Block (Non-Parity Keyboards)

In order to verify that software is not sensitive to the eighth bit ("parity bit") from Teletype it is useful to modify selected Teletypes so that keyboard characters always have their 8th bit spacing ("0") instead of the more usual marking ("1") 8th bit. The simple procedure is detailed on the attached sketch.

Machines which are modified should be prominently marked "Modified: Keyboard 8th bit zero."

To make 8th Bit
Alway Spacing ("1")
Slip A Piece Of #18
AWG Sleeving Over
The Short Contact
Wire. The Wire Will
Not Seat Between The
Insulating Tabs
When Sleeved.
