INTEROFFICE MEMORANDUM

SUBJ: PROPOSED RK05 DISK CARTRIDGE CLEANING PROCEDURE

ENGINEERING
CHANGE ORDER

FIELD CHANGE ORDER

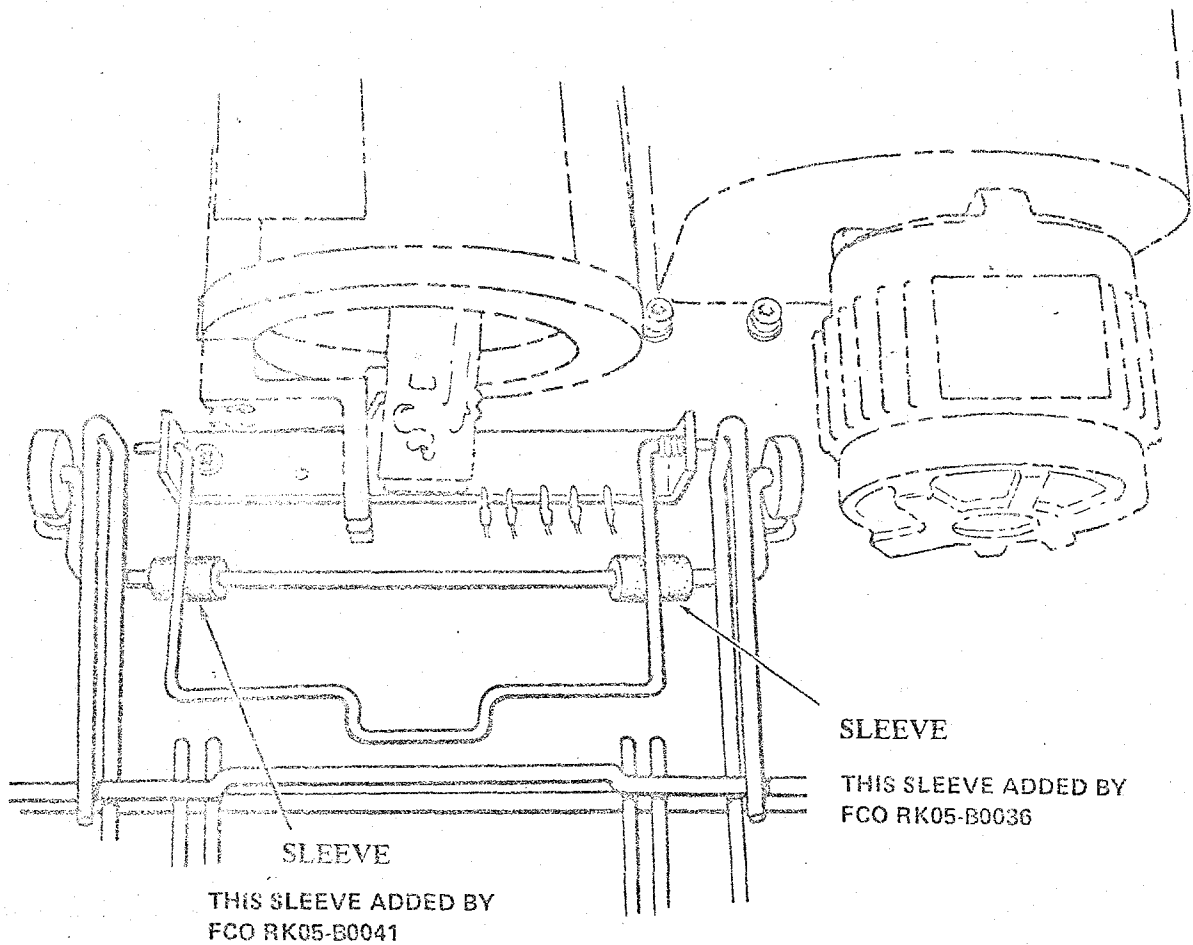
FCO INSTALLATION AND TEST PROCEDURE

The rubber sleeves are to be installed on the cartridge receiver at the points where the access door opener rests upon it.
(see illustration on FCO Page 2)

PARTS REQUIRED
Q2* 74-11271 Rubber Sleeve
