RK05
INTEROFFICE MEMORANDUM

SUBJ: RK05 DISK PACK SEMINAR

Title		DISK DESTRUCTION MADE SIMPLE		Tech Tip Number		RK05-TT-11	
All		Processor Applicability		AuthoMac Sloan/Bill Linton Rev 0		Cross Reference	
		8 11 15		Approval JIM BARCLAY Date 8/2/73		RK05-TT-10

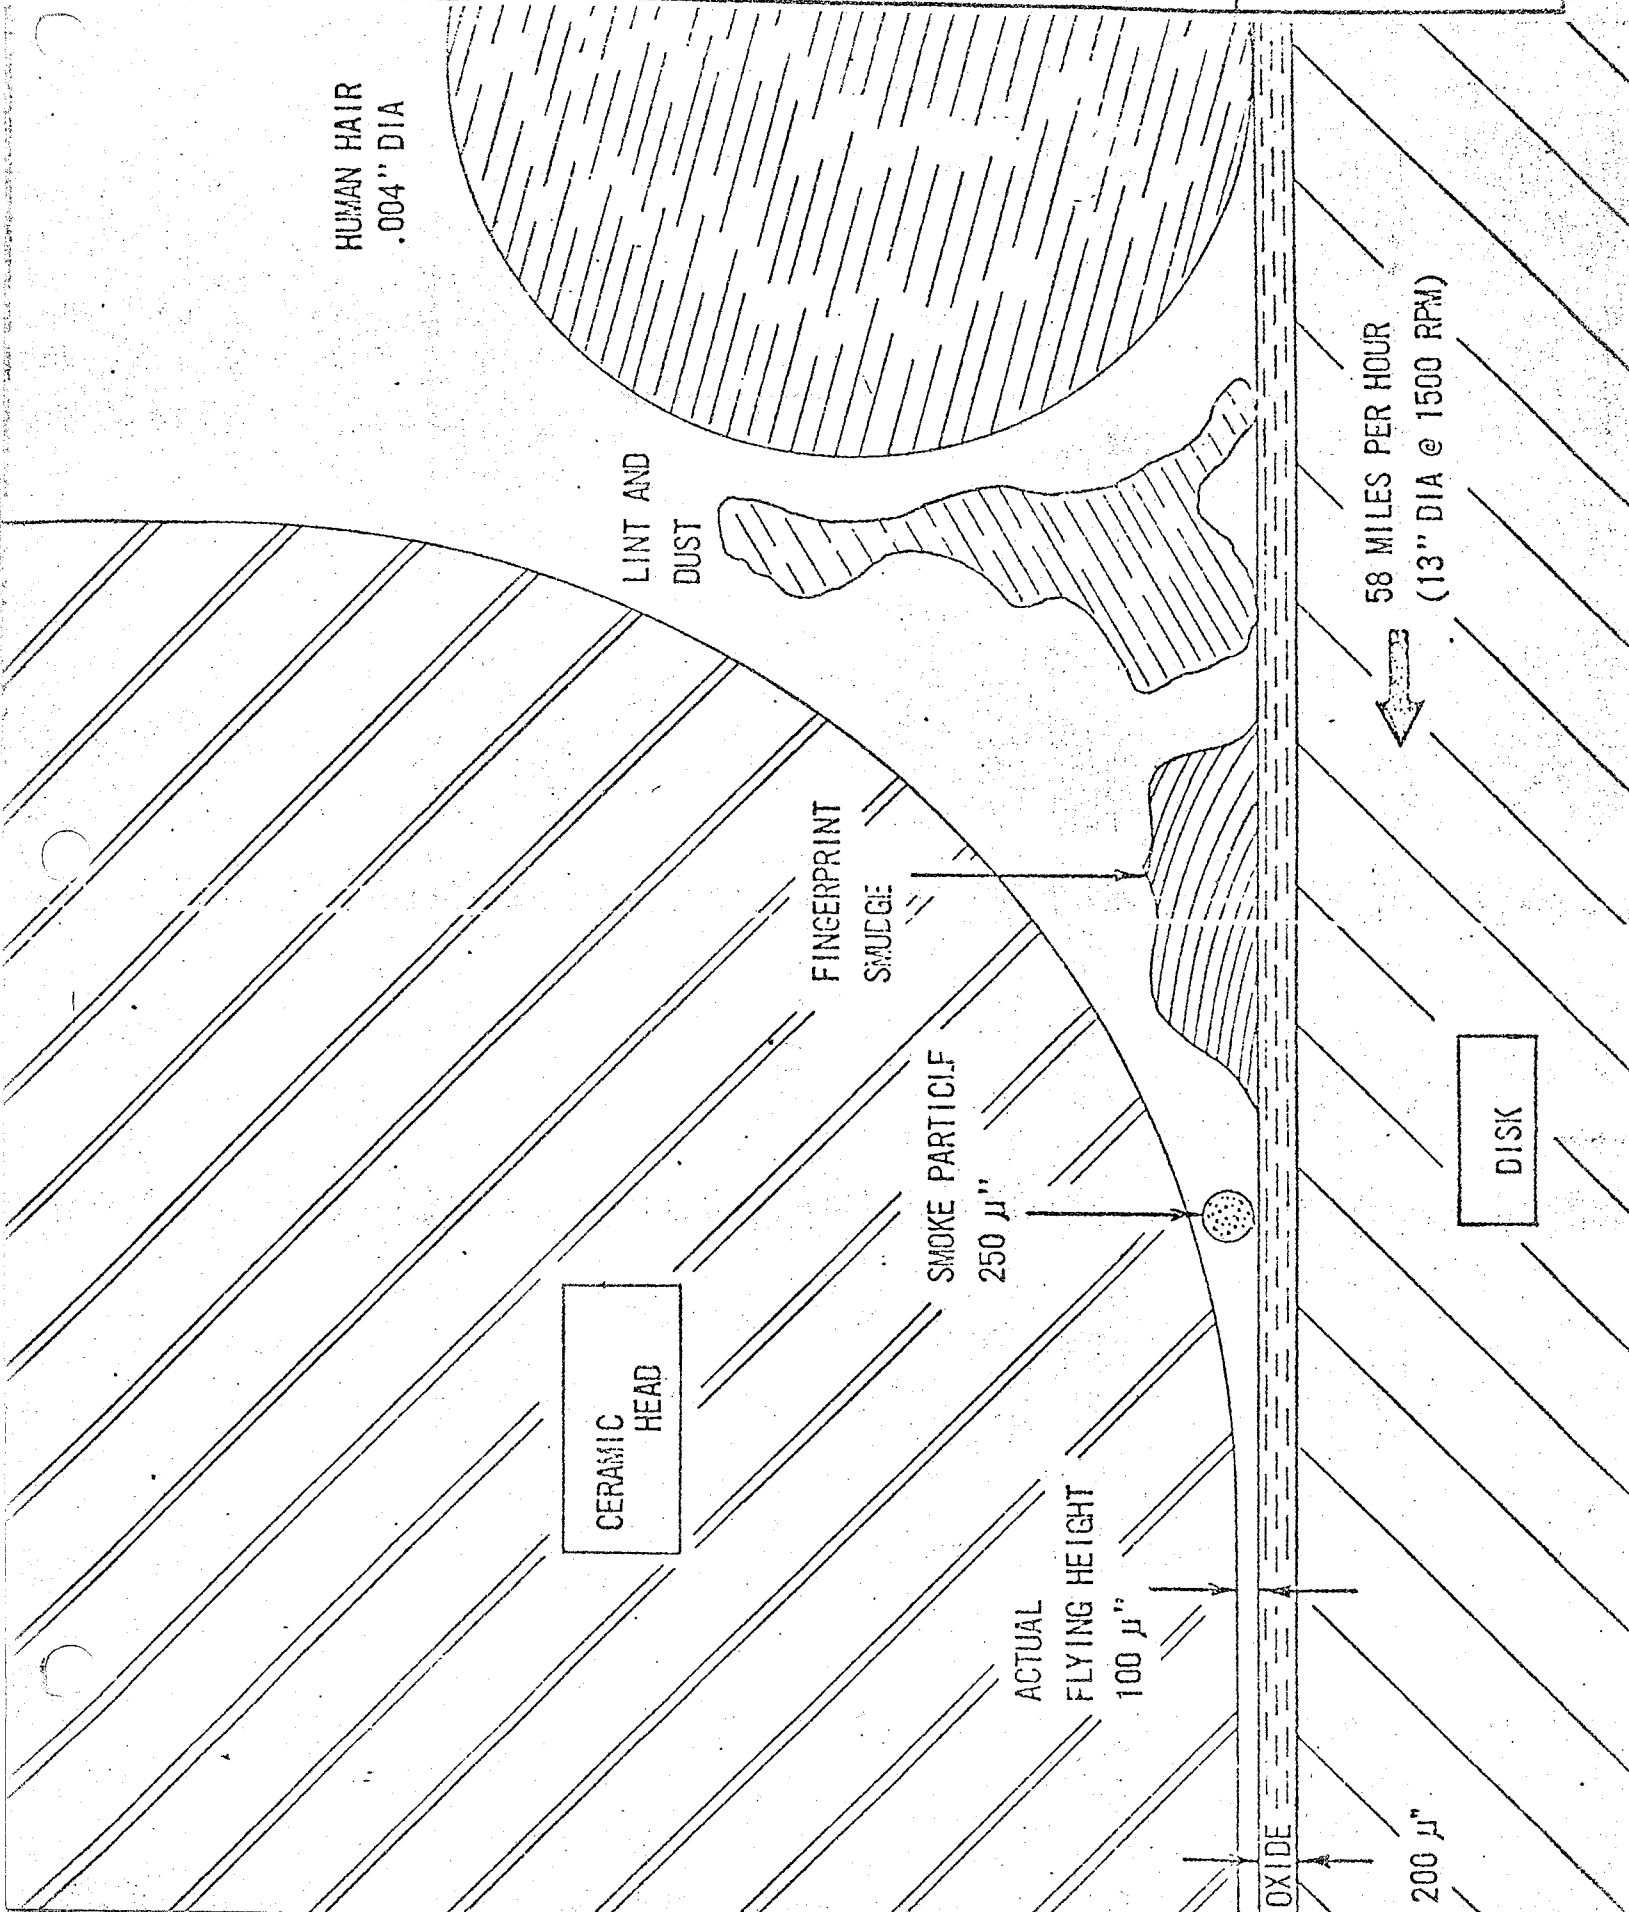
See attached picture. Yes, the head in an RK05 (or similar) disk drive actually "flies" closer than a finger print smudge or large smoke particle -- let alone a spec of dust, flake of dandruff or a hair. This may give you some idea why, when you can write your name in the dust on the outside of the disk cartridge, you may get disk oxide building up on the white ceramic head. Oxide build-up on the heads causes improper head flight and ERRORS if your're lucky-- CATASTROPHIC DESTRUCTION OF HEADS AND DISK if you're not. Keep the disk cartridge door shut and the disk in a clean bag or clean environment when not in the drive. And that's only dirt. There are other ways you can wreck a cartridge and/or drive; such as:

HUMAN HAIR
.004" DIA

LINT AND
DUST

FINGERPRINT
SMUDGE

SMOKE PARTICLE
250 μ"

CERAMIC
HEAD

ACTUAL
FLYING HEIGHT
100 μ"

OXIDE
200 μ"

58 MILES PER HOUR
(13" DIA @ 1500 RPM)

SO: Disks, like jokes in the presence of ladies, should be kept clean.
Do not bend heads!
Do not rape the drive with the cartridge.
Do not mix bad disks.
