1974 FIELD SERVICE TECHNICAL MANUAL

1st Edition December 1974

Copyright © 1974 by Digital Equipment Corporation

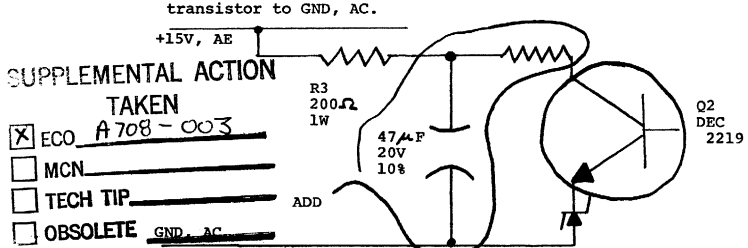
Problem: AD01A A/D converters that have AH04 and AH05 (Sample/Hold and Sign bit bipolar) options installed have been exhibiting a power supply problem. The problem is seen when more than three (3) AI24 modules (12 channels) are installed. The symptoms are that the positive 15 volt drops to 8 - 10 volts. This drop in the +15 volt line also causes the +5 to drop and the -15 likewise.

Cause: The cause of this problem is the use of the Deltron P/N 12-03185-3 Power Supply, which during power up, becomes overloaded and due to its inherent characteristics cannot recover from the overload condition.

Correction: An ECO A708-0003 adds a 47 ufd cap. 20V 10% and a 97Ω ½W resistor from collector of Q2 a DEC 2219 transistor to GND, AC.

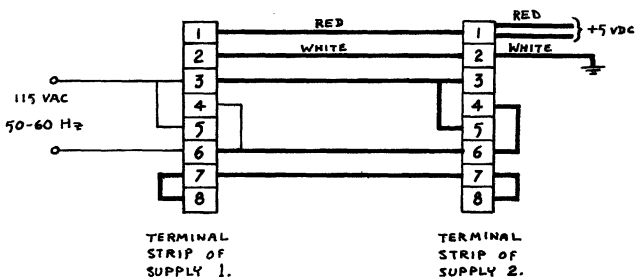
FIGURE BB714-B

Installation of a second 714 power supply requires the installation of the wires shown in Figure **BB714-B.**

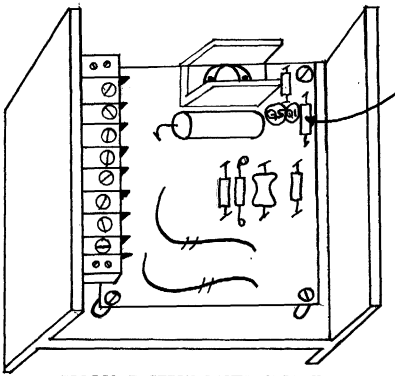
- FIGURE 1-714-A -

ECO Change	Priority	Units Affected	Purpose	Indications of Accomplishment
Change 1	Mandatory Except in cases where Change 2, below, was field installed,	Elasco-Eastern 714 Power Supplies shipped after 12/1/69. This is a manufacturer installed change only.	Filters line noise	1.0K OHM resistor installed to right of Q1 as shown in Figure 1-714-A.
Change 2	Mandatory in cases where the above change 1 was not installed by vendor.	Elasco-Eastern 714 power supplies shipped before 12/1/69. This is a field-installed change.	Filters line noise	1.0K OHM resistor installed in series with C3 as shown in Figure 1-714-B.

ELASCO-EASTERN POWER SUPPLY
WITH FACTORY-INSTALLED CHANGE

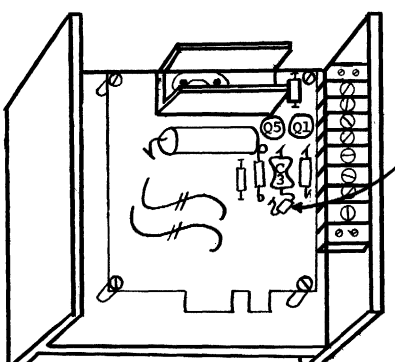
- Figure 1-714-B -

ELASCO-EASTERN POWER SUPPLY
WITH FIELD-INSTALLED CHANGE

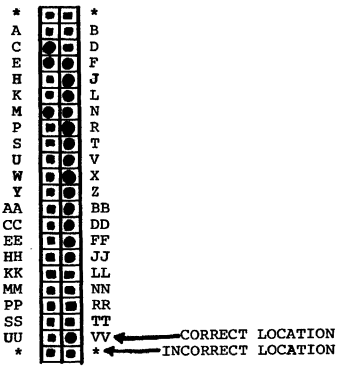
Some BC01V cables have made their way to the field which have the black wire that should be attached to pin VV on the Berg cable terminator connected to the unlabeled slot below pin VV. To correct this problem move the wire from the incorrect position to the proper one.

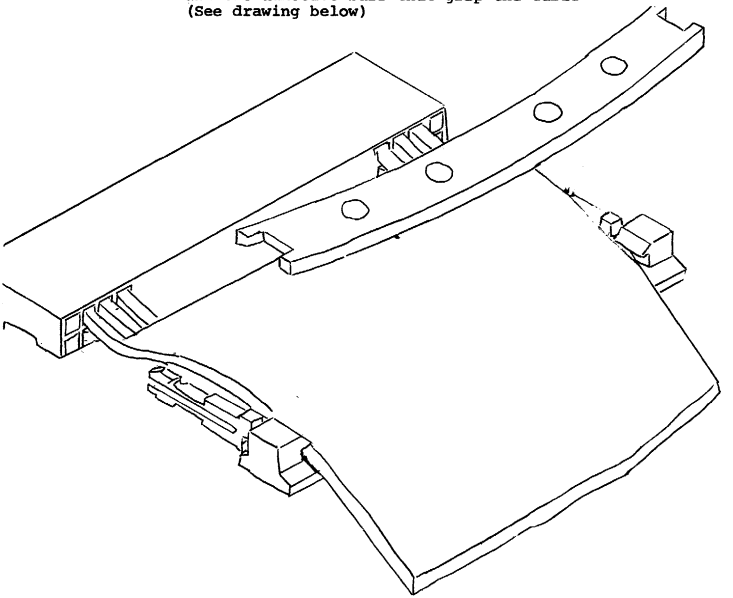
PROBLEM: 40 conductor cable coming out of Berg connector in cable assemblies such as BC08J, K, and L. Tends to get damaged with excessive handling.

SOLUTION: Berg make a cable clamp with four plastic fingers that lock into the unused pin holes at each end of the plug, and two adhesive bars that grip the cable (See drawing below)

DEC part number is 12-11166 for the complete assembly.
Berg part numbers are 65-33100 and 65-332001.
They may be ordered from the F.S stockroom under the DEC part number

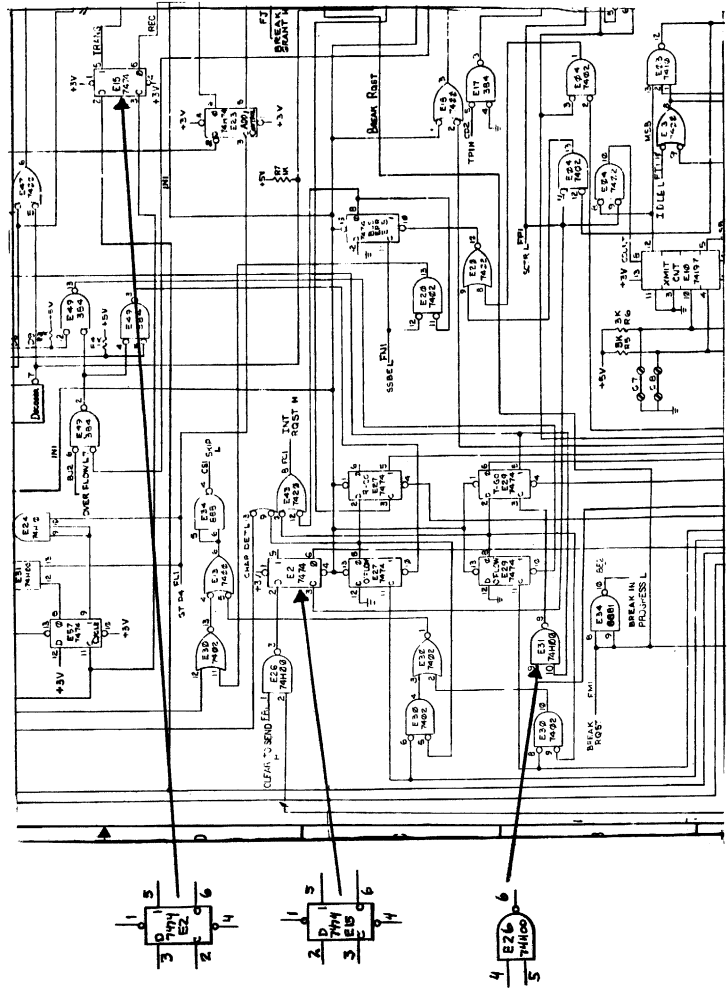
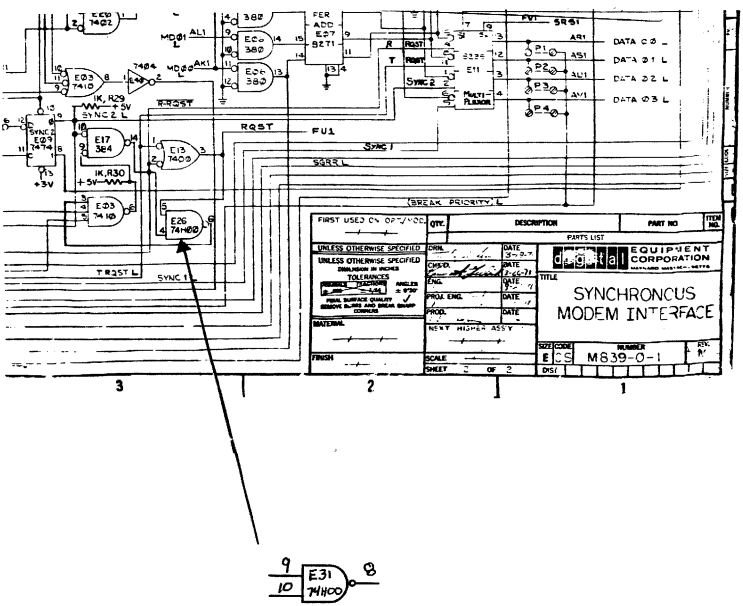
In the shuffle of ECO's and relaying out of the M839 module used in the DP8E several I.C.'s may have different locations on the module than noted on the prints. Following is a list of the problems, ECO's and print showing the problems.

ECO	Comment
M839	0001A	C.S. H is changed by replacing READ/WRITE F/F from RS type using E26 to CD type using E2. When relay out occurred this F/F became E15. Idle mode did not function properly. ECO added E26 to C input of T-GO F/F. Relay out used E31.
M839	0002	CS H adds CD type F/F to synchronize clear to send ECO calls out the use of E17 but relay out used E2.
M839	0005	CS L to correct a race condition a gate is added to SYNC 2 logic E26 is called for but because it is used in ECO 0001A E31 must be used in older boards.
M839	0001A	Add wire E2 pin 2 to E 3 Pin 6 ECO 0005 deletes all etch from E3 pin 6, if E3 pin 6 has a wire plus etch move the wire such that it runs from E2 to pin 2 to E11 pin 14.

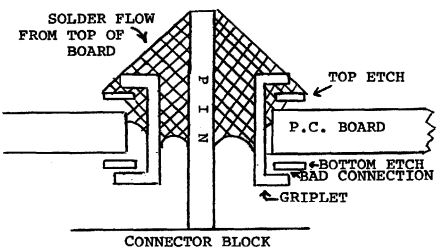
For a period the 50-08903 board used on the H851 over the top connector was manufactured using griplets to make the connection through the board. The griplet process can result in bad connections (anything from five (5) OHMs to open circuit), and was ECO'd out of the H851 manufacturing procedure as from September 1, 1972.

The only methods of checking are careful visual inspection under the board, using a solder sucker to clear a hole for inspection or OHM meter checking.

Also, an unknown number of connectors were assembled with the board on backwards. This gives no electrical problem, but could be confusing if you are counting pins for scoping and rely on the "A" etched on the board to find pin A. It could be pin V.

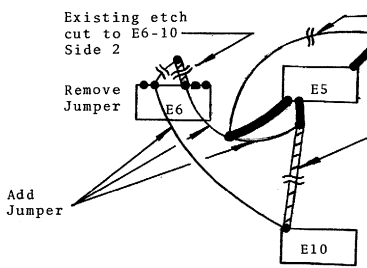
ECO M835-00003 is in error. A new ECO #M835-0004 has been generated to correct. The following sketches are correct.

[X] ECO M835-004

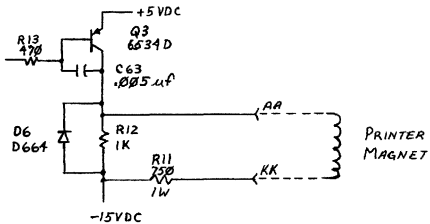
Some M8650, C.S. Rev. A prints were shipped without the hand made change added to the circuit which would make them C.S. Rev. B. The change to the circuit is shown below.

C.S. REV. A

C.S. REV. B

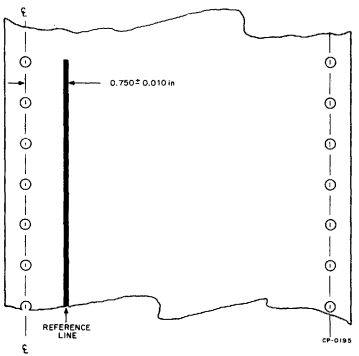
Figure 5-7 Checking Left Margin

2. Prepare a length of paper from the LA30 paper supply by drawing in a reference line in pencil or ink 0.0750 ± 0.010 inches in from the left hand sprocket hole center line. (Figure 5-7)

5. If the above conditions cannot be met, it is probable that the left-hand margin switch is damaged, worn, or improperly mounted. Readjust or replace the switch and repeat steps 2 and 3.

4. The position of the first character is adjusted by loosening the splined set screw on the drive pulley and then rotating the drive pulley on the shaft extension to correct the error found in step 3. Retighten set screw to at least 14 inches/pounds before testing.

6. CAUTION: Check to see if set screw on timing belt pulley is stripped or loose. This also causes similar problems as Step 4. If so retighten or replace.

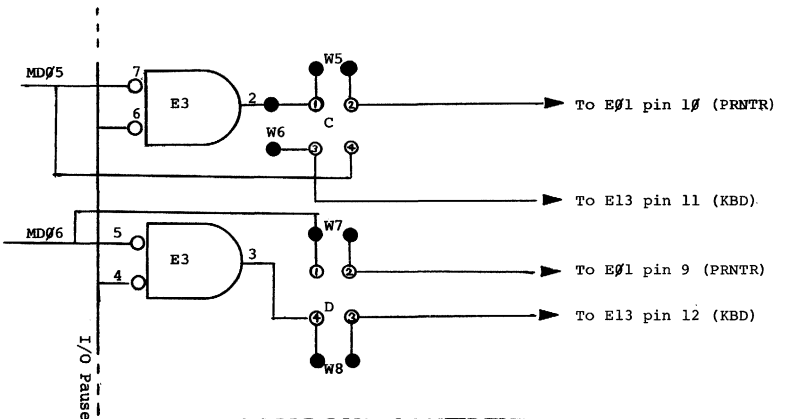
The same mistakes have been carried over into the LS8E (M8342) control. The drawing below also applies exactly to the C.S.Rev.Ø of that board.

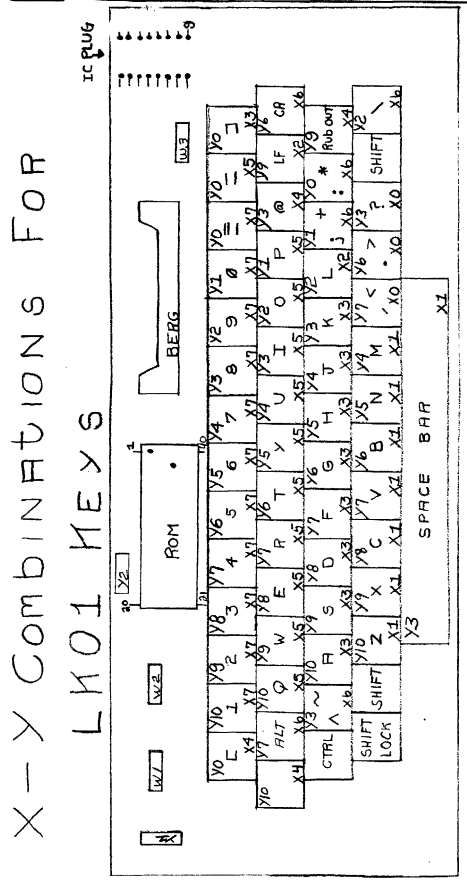
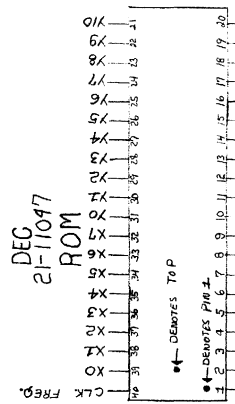
FIG. 1-1

9.	Dead or Intermittent Key Functions	Check with a scope the X/Y line decoding for your particular problem key or keys per fig 1-1. Most likely solution will be; replace the key transistor or the ROM. One of these solutions will fix most dead or intermittent key problems.

10. Check the oscillator voltage - The voltage can be checked at pin 9 of the I.C. plug. Reference Fig 1-1. No oscillation swap keyboard.

11. Check ROM Voltage (-12V) Check-12V (±1.5V) at pin 18 of the ROM. Ref. Fig 1-1. No voltage or not within range; swap keyboard.

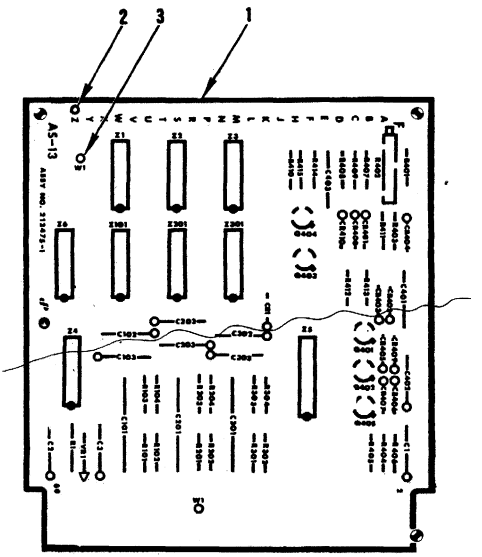
Z101, Z201, Z301

The AS13 module used in the 231Ø and 241Ø line printers manufactured by Data Products have spare gates used on the transducer amp which are prone to pick up noise. Pins 5 and 6 on the Z1Ø1, Z2Ø1 and Z3Ø1 I.C.'s should be tied to ground. (Module Pin 2 or 6Ø).

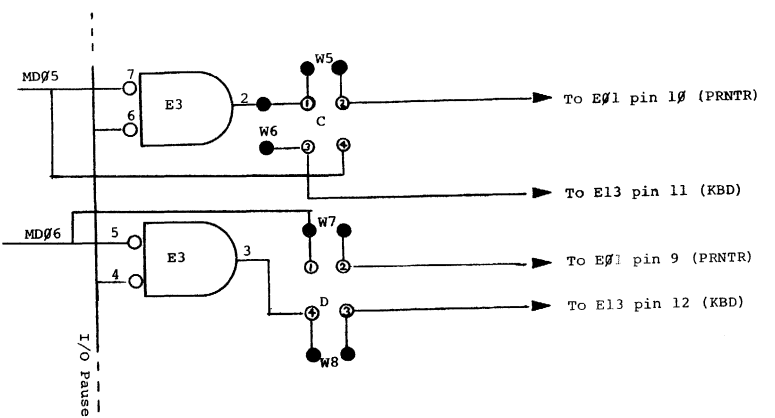
The same mistakes have been carried over into the LS8E (M8342) control. The drawing below also applies exactly to the C.S. Rev. Ø of that board.

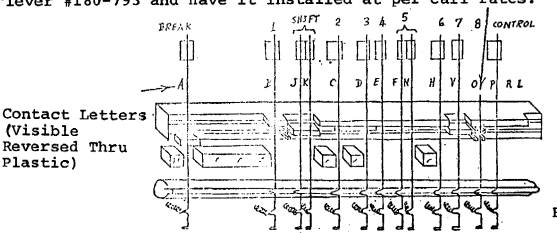
Right Side View Of Keyboard Contact Block (Non-Parity Keyboards)

In order to verify that software is not sensitive to the eighth bit ("parity bit") from Teletype it is useful to modify selected Teletypes so that keyboard characters always have their 8th bit spacing ("0") instead of the more usual marking ("1") 8th bit. The simple procedure is detailed on the attached sketch.
Machines which are modified should be prominently marked "Modified: Keyboard 8th bit zero."

To make 8th Bit Alway Spacing ("0") Slip A Piece Of #18 AWG Sleeving Over The Short Contact Wire. The Wire Will Not Seat Between The Insulating Tabs When Sleeved.

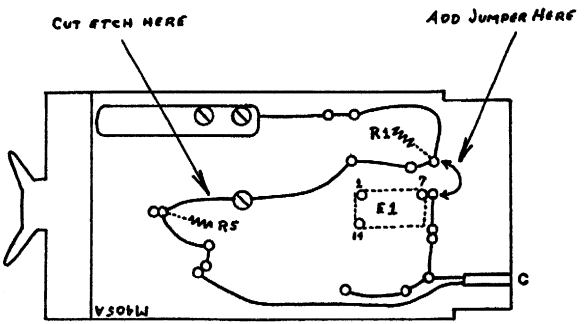
The accompanying sketch illustrates the ground path and the alteration points.

If an M405B is not available you may install the ECO yourself as follows: Looking at the etch side of the M405A (Handle UP), cut the etch between the bottom left shield screw and R5. Solder a piece of insulated wire from Pin 7 of E1 to the ground side of R1.

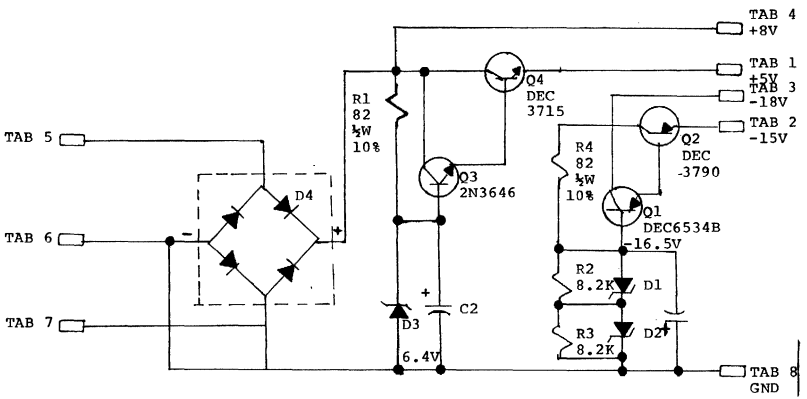
The circuit schematic for the PC04 regulator board is not presently part of the customer print set, which can cause some difficulties if you are trying to repair a power problem. The drawing below reflects the latest revision of the supply (created by ECO 5408308-003), and shows the change of R1 and R4 to 82 ohms, the new zener D3, and the elimination of the 0.1 ohm resistor (replaced by an external fuse) in the bridge circuit.

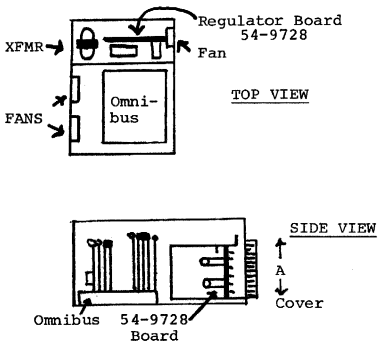
Title	FIT OF REGULATOR BOARD IN NEW 8M/8F CHASSIS	Tech Tip Number	PDP8M-TT-6
All	Processor Applicability: 8M 8F	Author: Jeff Blundell Rev: 0	Cross Reference
		Approval: Frank Purcell Date: 03/28/73

However, there is one problem you should be aware of. When the 54-9728 regulator board is manufactured it starts life as a board measuring approximately 6½" X 12". This should be eventually trimmed to its final size of 5.05" X 10.5", thus removing the crop marks on the etch. You will find many of the boards in your spares are oversize, with the crop marks still visible at the corners, and these will not fit in the new chassis, as dimension 'A' in the drawing will not tolerate a board wider than about 5.10.

Customers will not be impressed if you have to file or hacksaw a new board to fit in their machines, so check your boards carefully and trim them in the office before calling on a customer with power problems in a new style 8M or 8F.

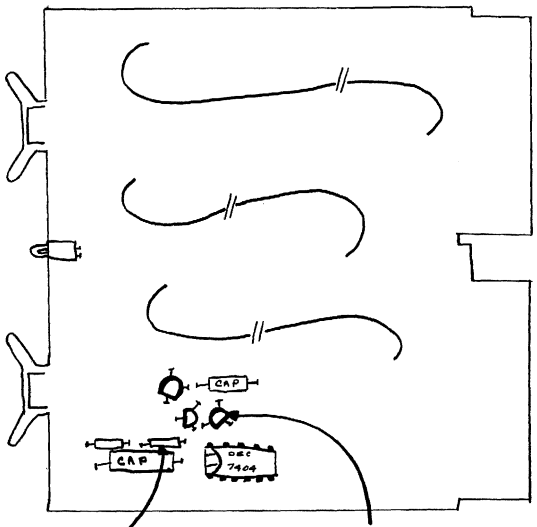
- FIGURE 1-M774-A -

M774 Instruction decoding PDP-14L	M774 00001	MANDATORY	M774 etch Rev. C	insures initial signal on power dip.	M774 is etch Rev.C Q3 is DEC 2219, R16 is 22 OHM (see physical layout next page)

NOTE: No M774 less than etch revision C should be used in the field.

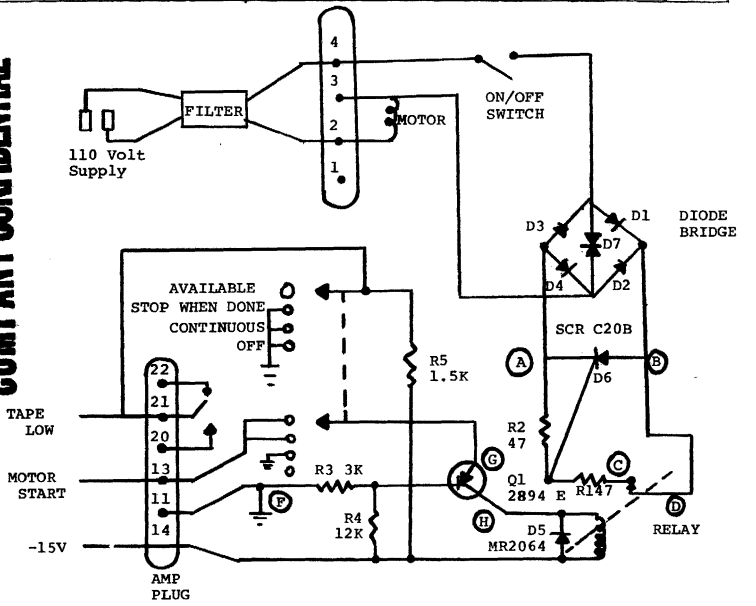
FIGURE 1

One other problem found in the punch control circuit is resistors R_1 and R_2 (47 ohm) burnt. This was caused by the SCR having an open cathode. When the relay contact closed, 110 volts is dropped across R_1 and R_2 and if SCR fails to fire, R_1 and R_2 will burn up.

For replacement part numbers for any of the above mentioned items, refer to punch control circuit schematics D-CS-7005095-0-1, Revision A.

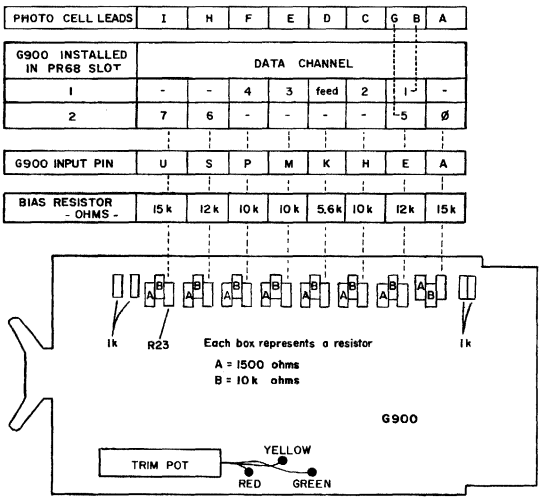
FIGURE 3

Revision F boards will be released shortly and will incorporate the final scheme of compensating bias resistors. The resistor scheme (which is shown above) should be implemented in the field on all older boards.

Revision B boards can be repaired by simply connecting the trim pot leads to the proper split lug (see Fig. 3 next page).

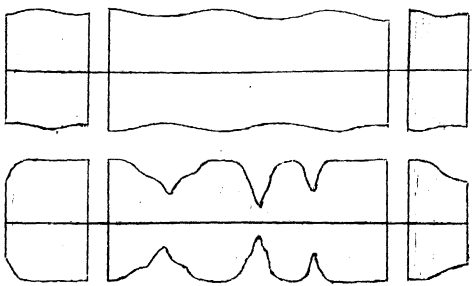
F) The first sketch indicates a good surface, only minor dips will be observed in a revolution.
G) The second sketch indicates that the surface is dirty and has started scoring the surface. The display on the scope will have sharp jagged decreases in amplitude. Where a good surface will have a minor and more gentle decrease and increase.
H) This procedure should be repeated on all timing tracks (three) and on randomly selected data tracks.

This method will give you the general condition of the surface, however, if the diagnostic still gives error on a specific track and address this problem should be confirmed before replacing disk. Only a minor adjustment may be required to correct the problem.

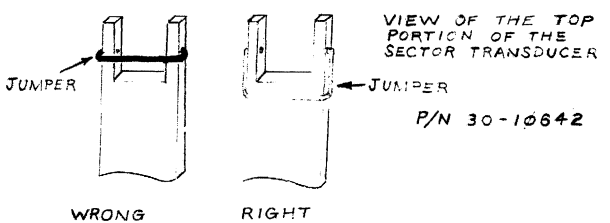
A number of improperly wired sector transducers were produced some time ago. We feel that our logistics system has been purged of these defective parts, however, as a precautionary measure, this tech tip is being issued. Below, both types of transducers are illustrated. Should replacement become necessary, it is suggested that a visual inspection be made. Improperly wired transducers should be disposed of and replacement ordered from Maynard or respective regional stockrooms.

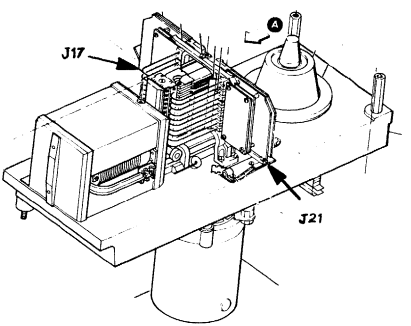
The ground assembly should be carefully inspected at each P.M. The broken wire may be difficult to detect, as it may retract into the shield.

If you have intermittent read/write errors that show up either on all "A" side heads or all "B" side heads, check for a loose ground connection on J17 (R/W deck plate left) or J21 (R/W deck plate right). Refer to figure below.

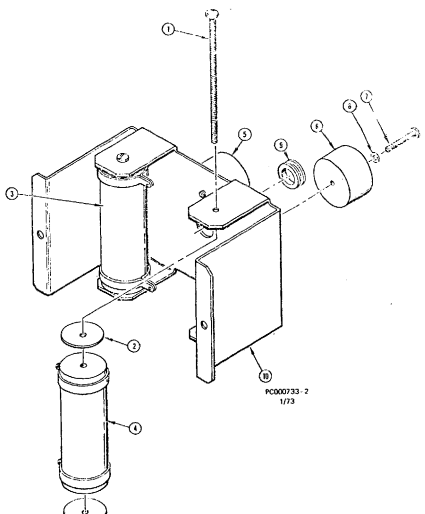
The following problems have been encountered in drives in which the resistor bracket assembly (P/N 88000733-X) has either been miswired or contained resistors of the same value: seek incomplete; seek errors; or dropping ready. Should a drive exhibit these symptons, verify that resistor R13 is 0.5 ohms and connected between PD1-7 and PD1-14, and resistor R14 is 0.8 ohms and connected between PD1-15, and inductor L2. If resistors R13 and R14 are wired in reverse, change the wiring to agree with above instructions. If resistors R13 and R14 are the same value (i.e., 0.5 ohms or 0.8 ohms), replace the resistor bracket assembly.

In addition to the above problems, the parts catalogs for 714 and 715 type drives depict R13 and R14 in the wrong position in the bracket assembly. Replace the Resistor Bracket Assembly figure in the parts catalog with the following figure.

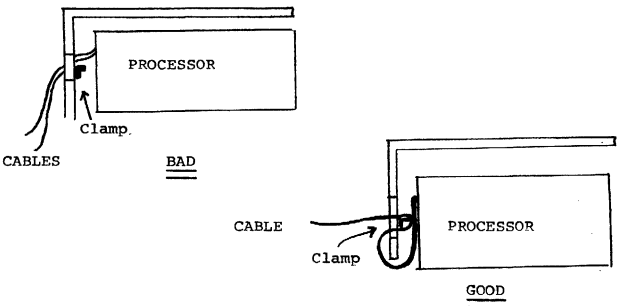
It is not true that cables need to be unplugged so that they can be threaded back through the hole in the rear of the super cover when you wish to remove the super cover for service.

The correct cable run is shown below:

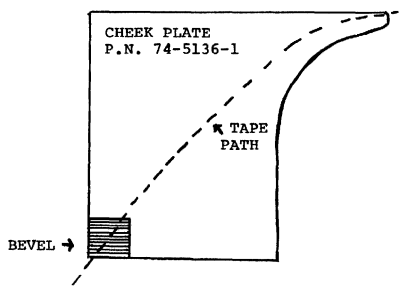
If any of the unbeveled cheek plates or any plates with burrs are installed they will cause excessive tape flutter and skew.

Be sure to check your local supplies and discard or return to Maynard Field Service stockroom any improper plates with the necessary comment.

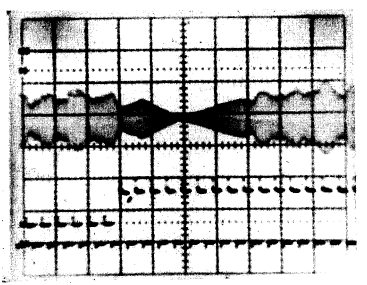
The severity of the bounce is directly related to the degree of mismatch between the driving motor and its capacitor. Drag motor mismatch will not cause or prevent bounce. A normal TU56 with proper wear plate contact, even with severe driving motor mismatch, will show up to a 20% reduction in the peak to peak timing track analog output voltage. A 40% - 50% loss of amplitude due to bounce will cause random marktrack errors, and greater than 50% loss of amplitude will cause fairly frequent marktrack and data errors. These figures are for a de-skewed TU56; bounce can be aggravated by out of skew guider and heads. Once a particular dectape has worn widthwise to the point that it is free to move vertically, bounce is inevitable and the tape must be discarded. Bounce is also related, occasionally, to power supply grounding problems. Before you suspect tape wear problems and order expensive tape guide parts, its probably a good idea to install ECO #725-12. This is particularly the case if marktrack errors occur with equal frequency throughout the life of the tape, or if marktrack errors occur more frequently when both drivers are on-line, instead of one on-line. ECO #725-12 has cured more than one intermittent TU56.

NOTE: Timing track output during start/stop sequence when tape is accelerating/decelerating should not be confused with tape bounce. This is due to normal gain changes during direction changes.

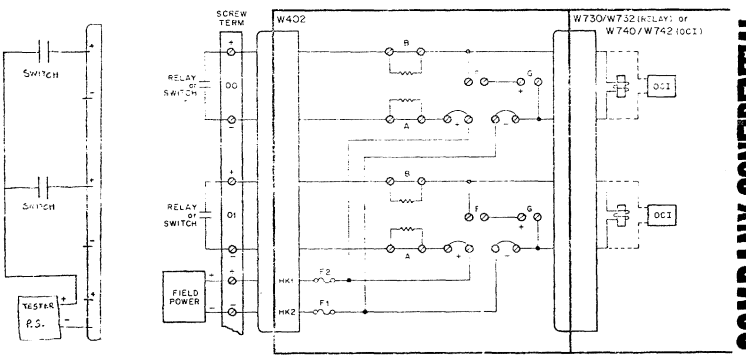
Because of the way in which the UDC tester connects to the W402 signal conditioning module, one of the voltage scaling resistors is not included in the circuit, resulting in a tester voltage setting that is different from the customers field power source.

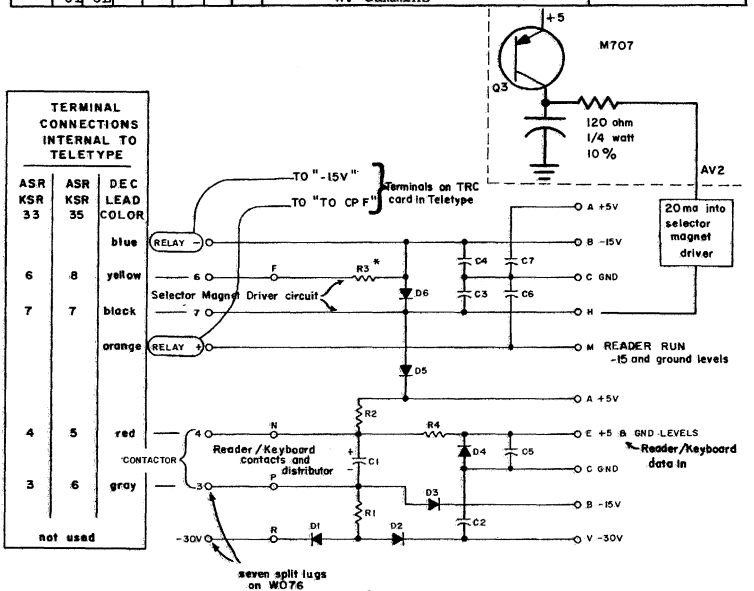
Title	TELETYPE CONNECTOR W076	Tech Tip Number	W076 TT#1
All	Processor Applicability: 8I 8L	Author	Rev 0
		Approval W. Cummins	Date 7-31-72
			Cross Reference

* R3 changed to 820 ohm 1/2 watt 20%
