<b>digital</b>	<b>FIELD SERVICE TECHNICAL MANUAL</b>				Option or Designator
	12 Bit <input checked="" type="checkbox"/>	16 Bit <input checked="" type="checkbox"/>	18 Bit <input type="checkbox"/>	36 Bit <input type="checkbox"/>	AD01

Title AD01 MULTIPLEXER F.E.T. Leakage				Tech Tip Number AD01-TT-1	
All Processor Applicability			Author R. Adams	Rev 0	Cross Reference
8's	11's		Approval J. Blundell	Date 12/07/72

Title AD01 Source Impedance Problems				Tech Tip Number AD01-TT-2	
All Processor Applicability			Author A. Thompson	Rev 0	Cross Reference
8's	11's		Approval G. Chaisson	Date 12/08/72

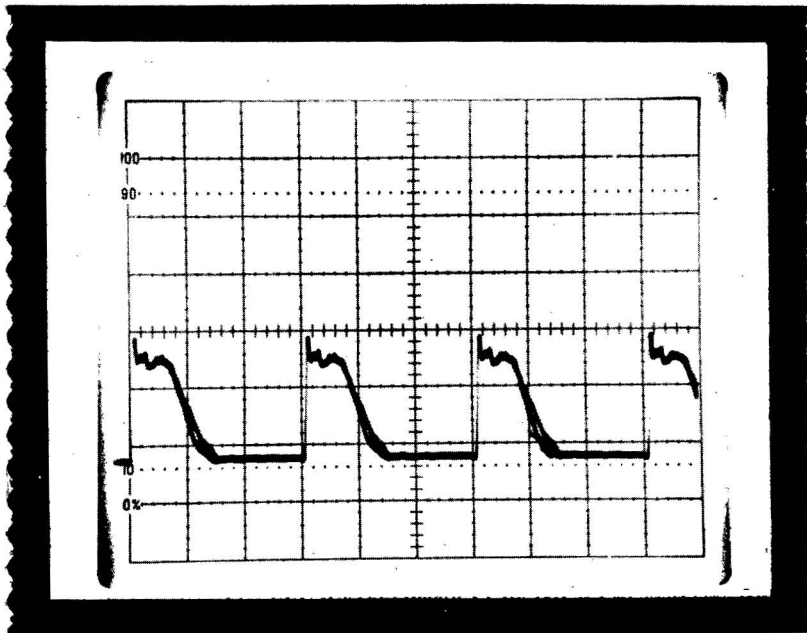
FIGURE 8

7. Observe Jack 7, again while depressing write 2, the output should resemble Figure #8, leading edge to leading edge should be approximately 600 nsec. Figure #8 represents 200 nsec per CM if adjustment is necessary, go to 7A.

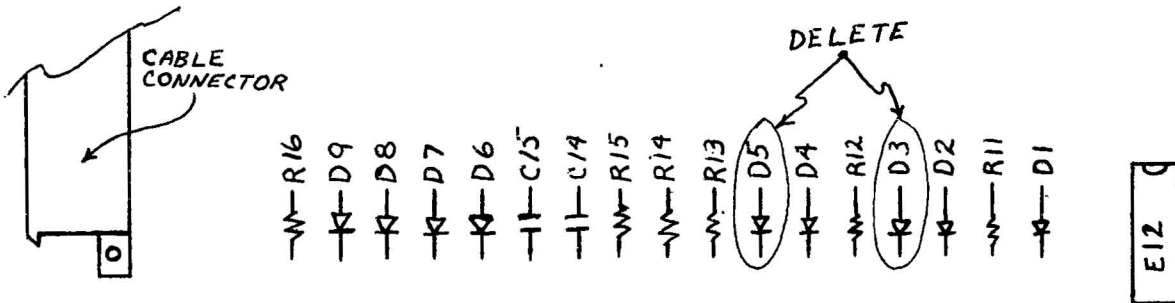
The only modification that is required to the module is to delete two diodes (D3 and D5). These diodes are located in the upper left hand part of the module as shown in the picture below.

With these two diodes removed the DK8E clock diagnostics (Maindec-8E-D8AB-D-(D)) will not run. To have an operative diagnostic two locations will have to be changed. They are:

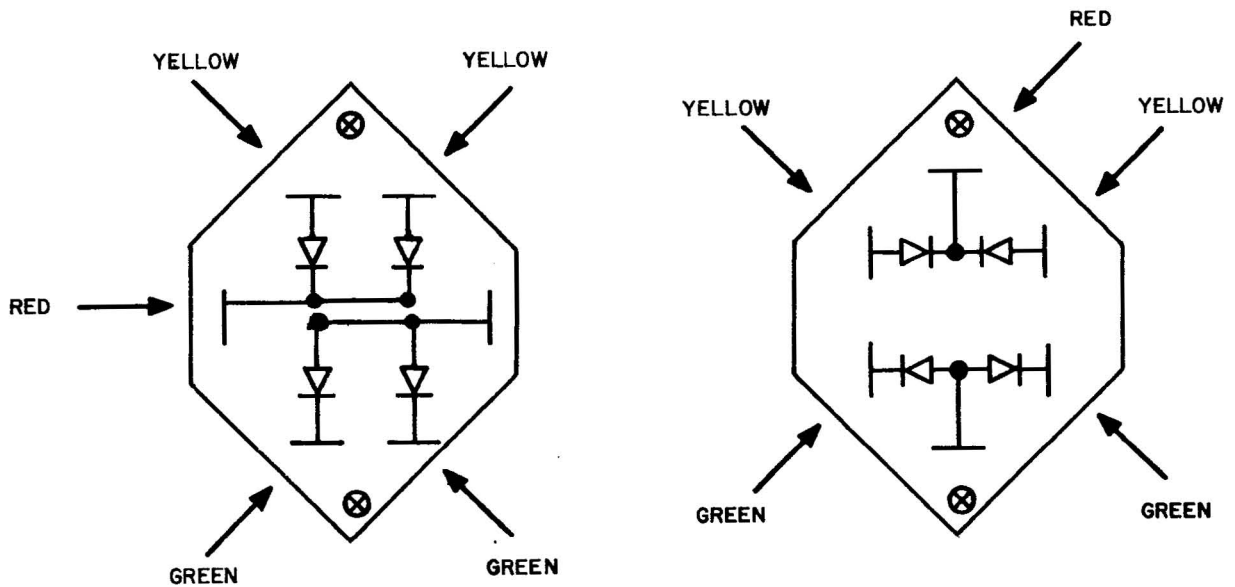
Some confusion has arisen from the fact that DM-1 rectifier packages produced by Solatron have their physical terminal configuration shifted 90° with respect to those manufactured by Motorola. All internal connections, color coding, and electrical characteristics are identical for both units.

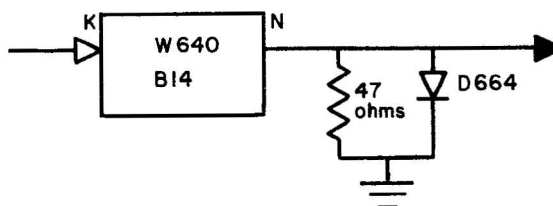
Print D-BS-637-0-1 (at B8) indicates a diode, resistor network to ground.

*If the network has not been installed, random data errors can occur which will not be detected by the off-line diagnostics 08-D8HB, LA, FA or NA. If the diode has been installed with its polarity reversed, all data will be incorrect, shifted left some indefinite number of bits (one or more).*

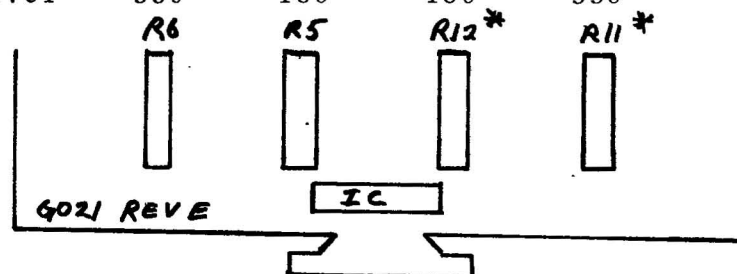
- 1) Rev. D and earlier are considered -3V slice level.
- 2) Rev. F and later are considered -4V slice level.
- 3) Rev. E can be either -3V or -4V and it is the only revision that can be changed. The resistors to change are listed below:

R6	R5	R12	R11
-3V slice level	300	330	330	300
-4V slice level	330	180	180	330

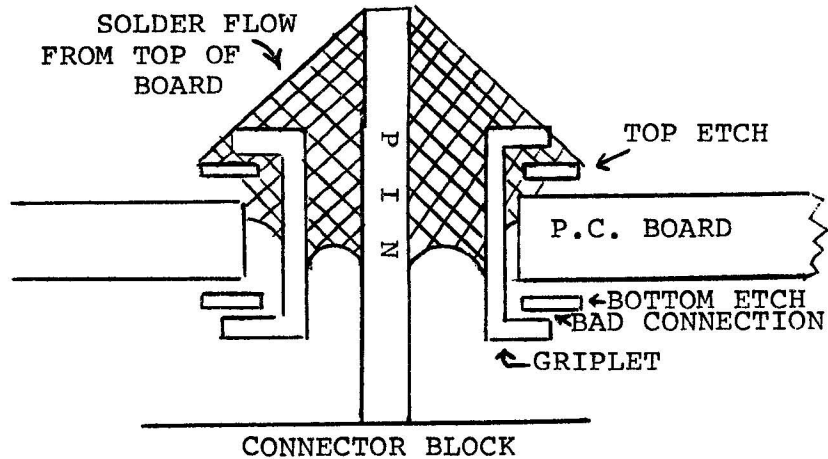
For a period the 50-08903 board used on the H851 over the top connector was manufactured using griplets to make the connection through the board. The griplet process can result in bad connections (anything from five (5) OHMs to open circuit), and was ECO'd out of the H851 manufacturing procedure as from September 1, 1972.

The only methods of checking are careful visual inspection under the board, using a solder sucker to clear a hole for inspection or OHM meter checking.

Also, an unknown number of connectors were assembled with the board on backwards. This gives no electrical problem, but could be confusing if you are counting pins for scoping and rely on the "A" etched on the board to find pin A. It could be pin V.

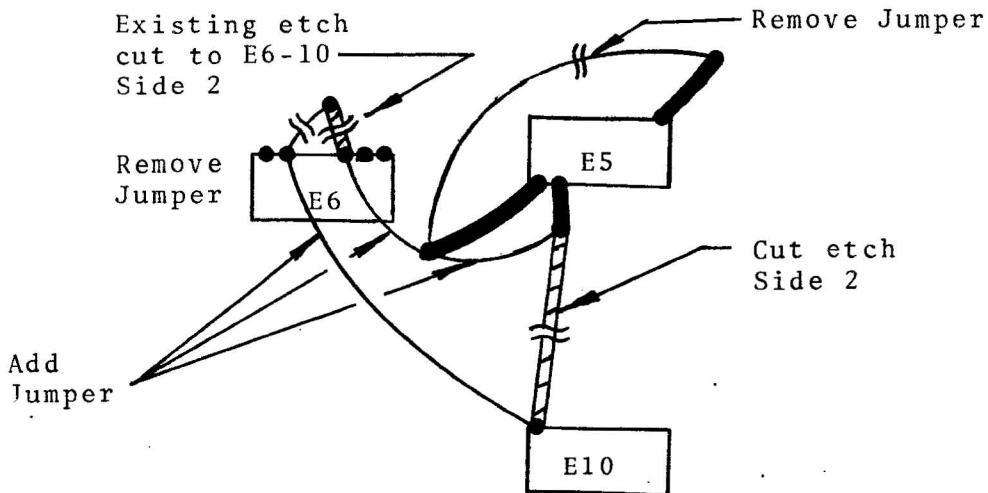
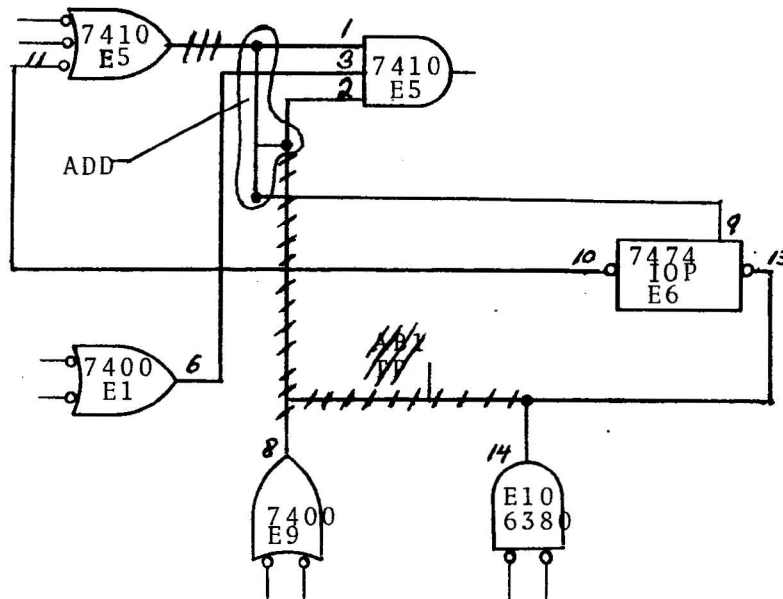
ECO M835-00003 is in error. A new ECO #M835-0004 has been generated to correct. The following sketches are correct.

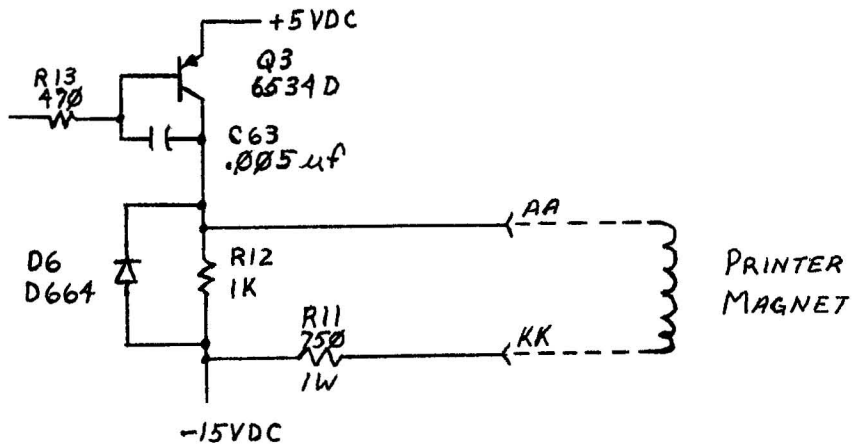
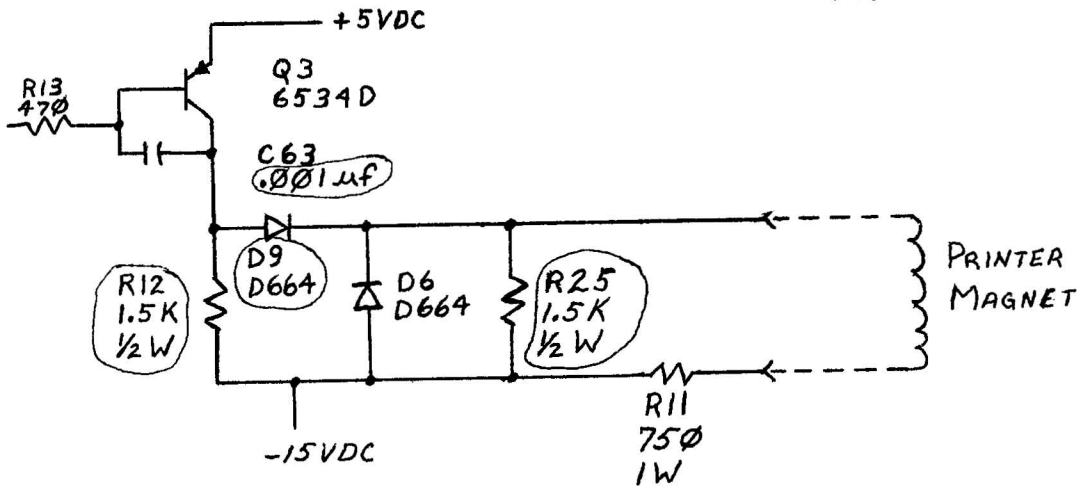
Some M8650, C.S. Rev. A prints were shipped without the hand made change added to the circuit which would make them C.S. Rev. B. The change to the circuit is shown below.

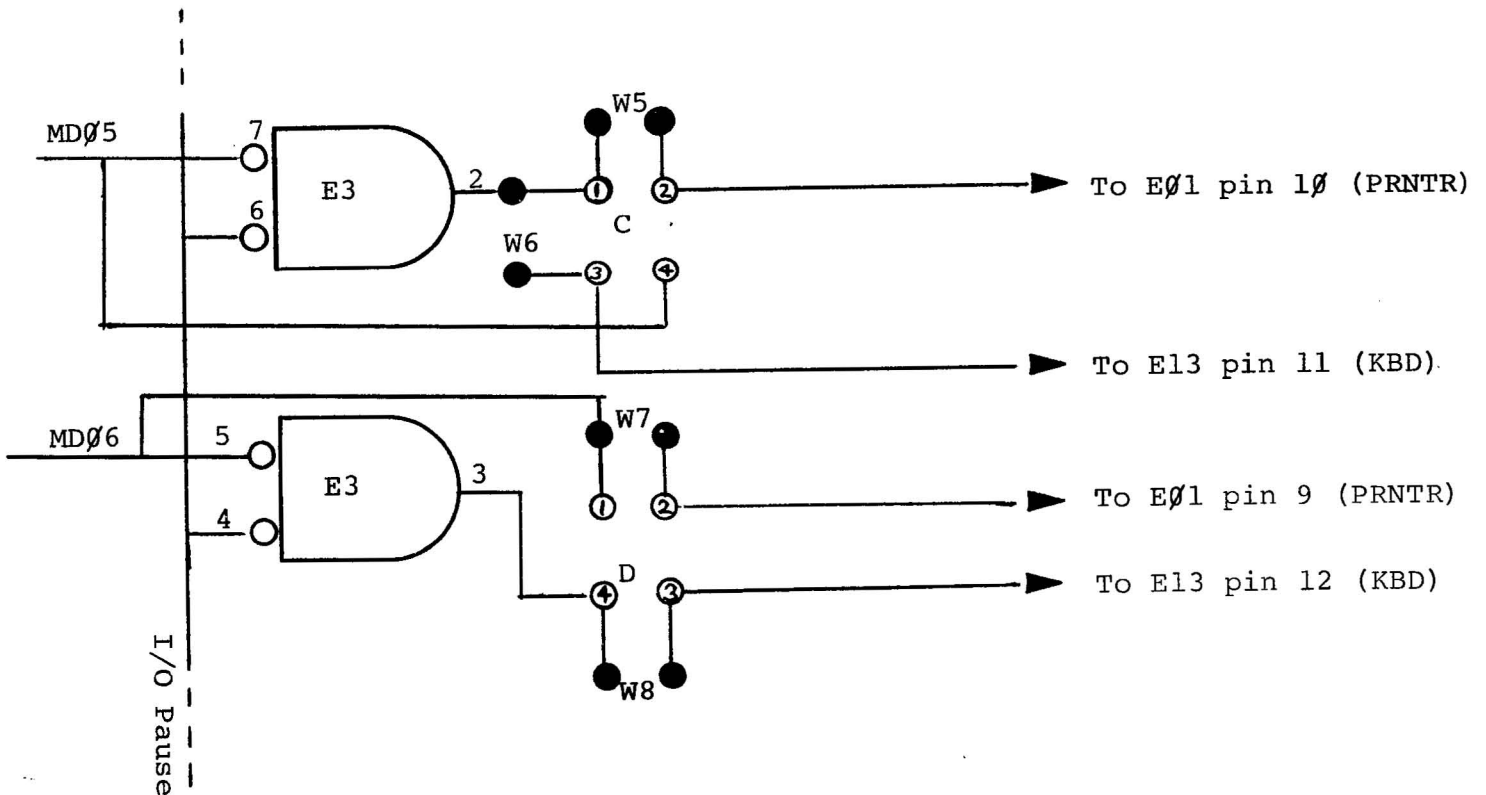
The fault symptom will typically be either wrong sense of bits 5 or 6 in the decoded IOT, or MD bit 6 always constant on the omnibus.

The same mistakes have been carried over into the LS8E (M8342) control. The drawing below also applies exactly to the C.S.Rev.0 of that board.

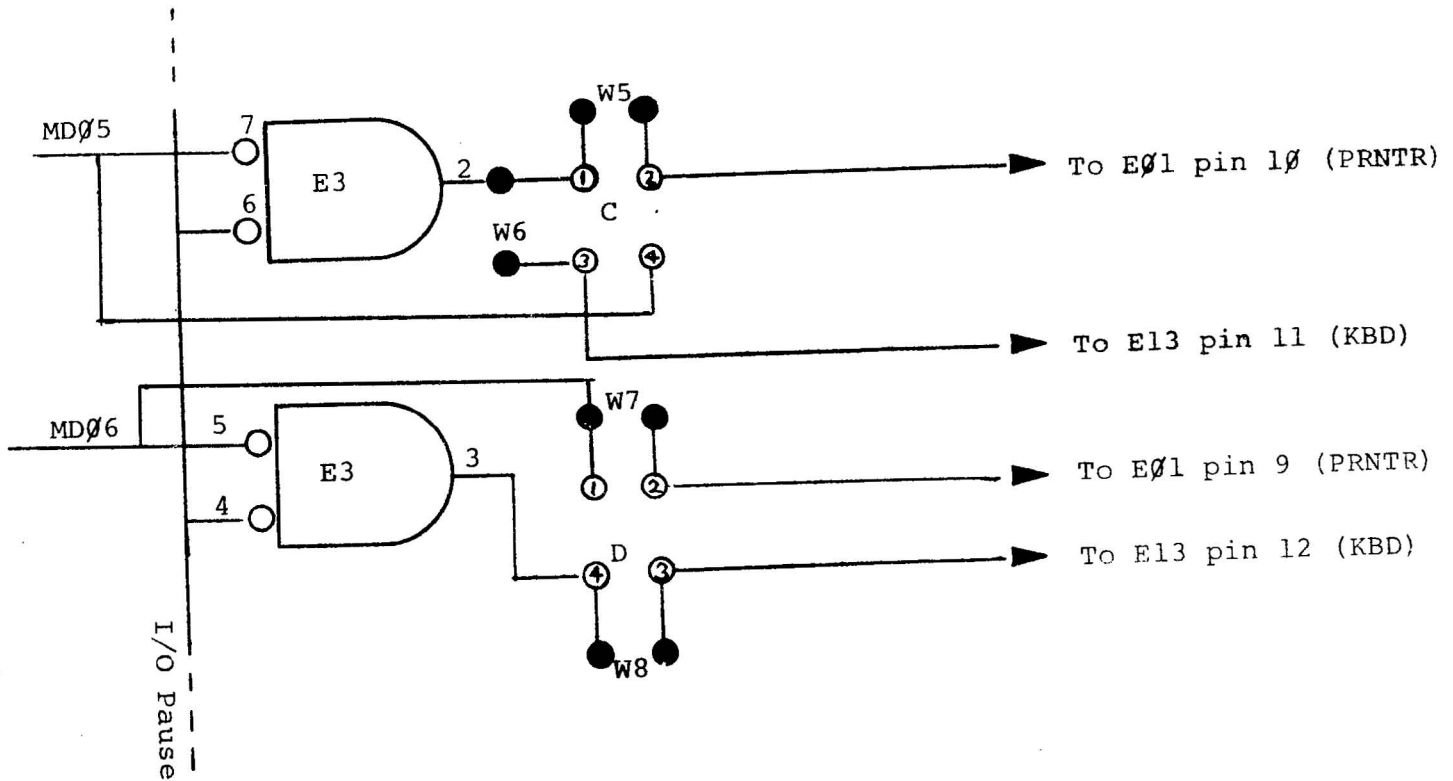
The fault symptom will typically be either wrong sense of bits 5 or 6 in the decoded IOT, or MD bit 6 always constant on the omnibus.

The same mistakes have been carried over into the LS8E (M8342) control. The drawing below also applies exactly to the C.S. Rev. 0 of that board.

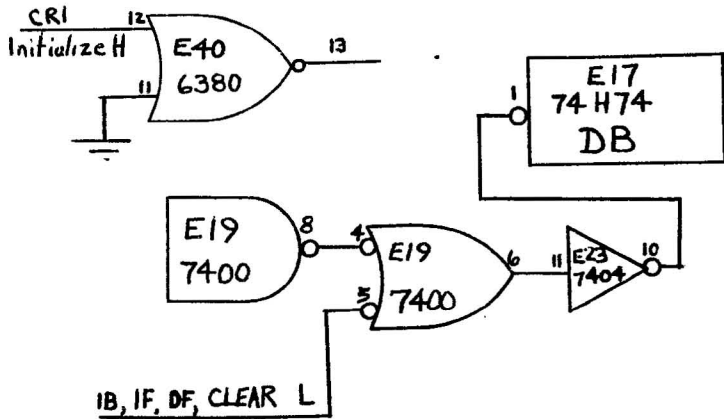
Rev. B Print M837-0-1, 2 of 3

It may be found impossible to manually clear the "User Mode" bit (except by turning power off and on) on M837 modules at etch Revision B, even though the handle stamp indicates the module has been ECO'd to circuit schematic Revision C or D.

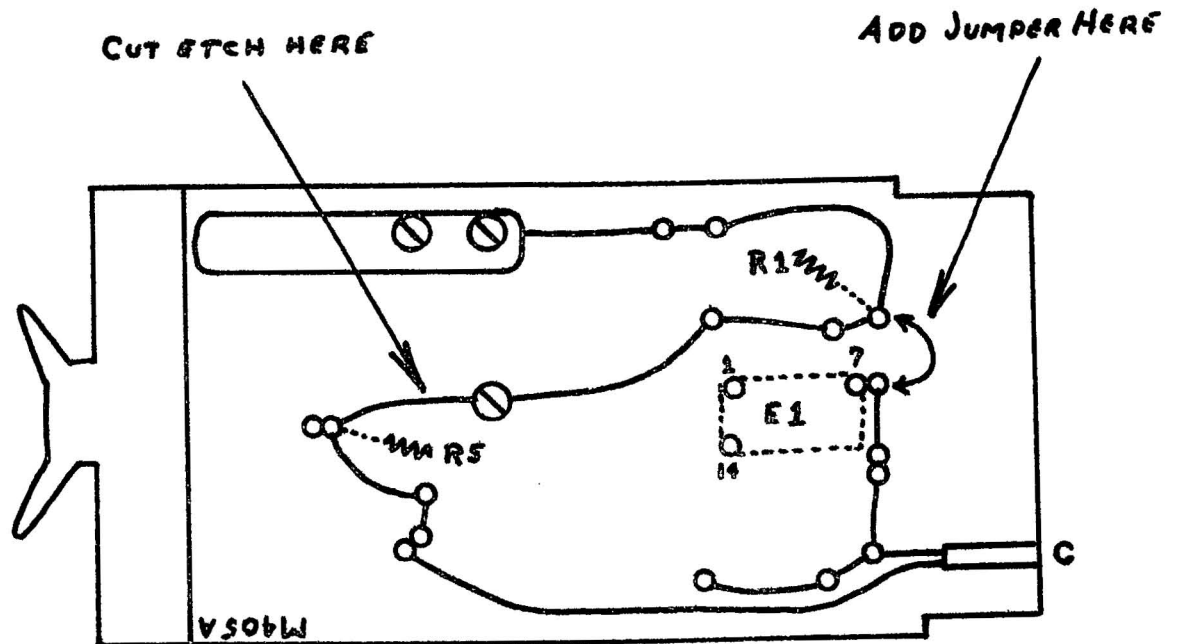
The M405A Crystal clock has been known to produce a multiple pulse output when operating in the 5-10 and 19-20 KHZ ranges. If you experience this problem, replace M405A with M405B, which incorporates ECO M405-01. This ECO isolates the analog circuitry ground from the tank circuitry ground, and both widens and shortens the tank ground path to reduce inductance, thereby eliminating the problem.

The accompanying sketch illustrates the ground path and the alteration points.

If an M405B is not available you may install the ECO yourself as follows: Looking at the etch side of the M405A (Handle UP), cut the etch between the bottom left shield screw and R5. Solder a piece of insulated wire from Pin 7 of E1 to the ground side of R1.

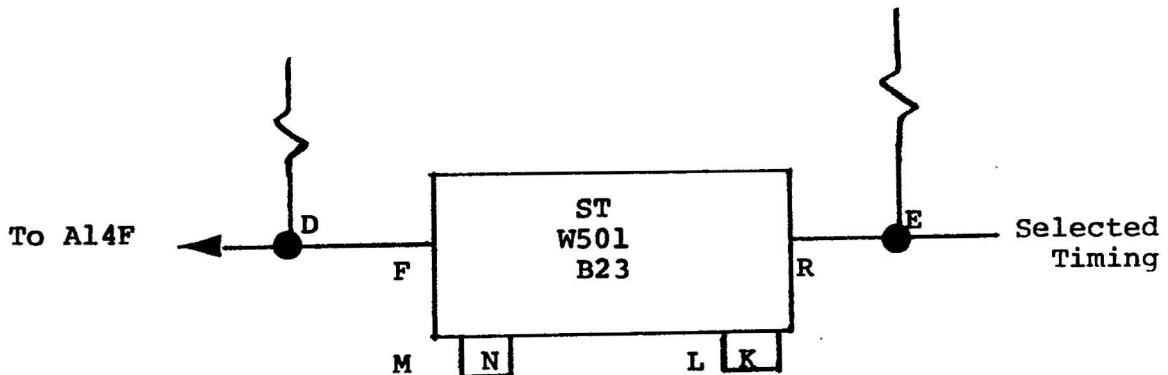
Reference print PA60-A-4 circuit changed as follows:

The W501 Schmitt trigger (B32) might not be operating properly. The output pulses may vary radically in width and frequency with the punch running constantly. The problem may be that pin R, the input is clamped to about 2¼ to 2½ volts. The problem can be solved by taking the 2 ma. clamp load (Pin D) off the input (Pin R), and the 10 ma clamp off the output (Pin F) and switching them. This results in having the input clamped with 10 ma clamp load, and the output clamped with the 2 ma clamp load. This causes the input to go to -3V and, as a result, reliable operations of the W501.

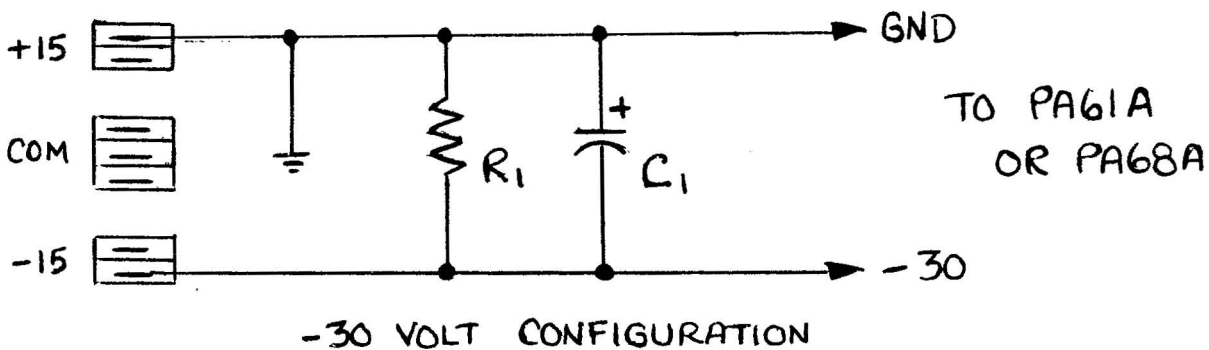
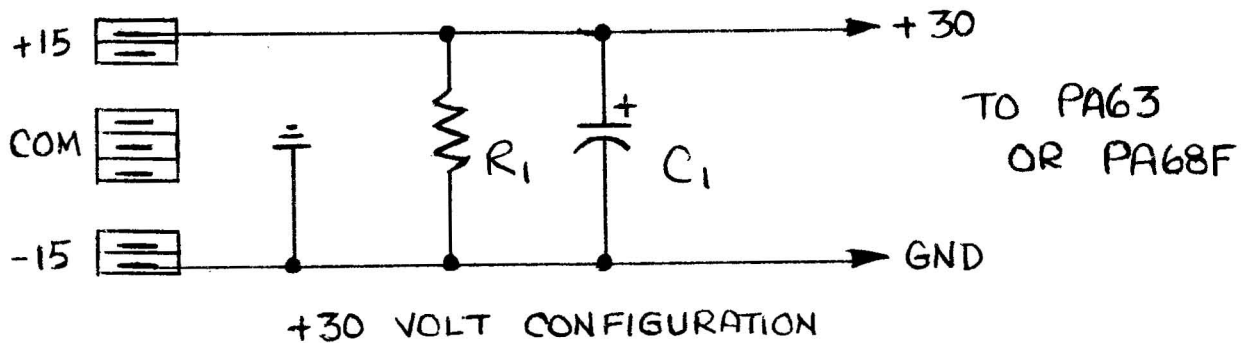
FIG. 1 - G799\* POWER SUPPLY

There are two problems associated with the 30 volt power supply used on all typesetting systems. This is the G799 power supply (G799A for 240V/50 HZ) which supplies -30 volts for the PA61A and PA68A, and +30 volts for the PA63 and PA68F controls. The absence of a bleeder resistor on the 30 volt line has caused reader modules to be blown when inserting or removing the reader cable even with all power turned off. The other problem is excessive noise on the line when both the reader and punch are operating, causing various intermittent problems.

Both of these problems were solved by ECO number PA61-A-00003, but most units shipped to date have not had this change incorporated. The ECO consists of addition of a 500 ohm/25 watt bleeder resistor and a 50 mfd/50 volt bypass capacitor in parallel across the 30 volt output. This change applies to all controls (PA61A, PA68A, PA63, PA68F) and must be added if not already present to expect proper operation. See Figure 1 for correct wiring and parts numbers.

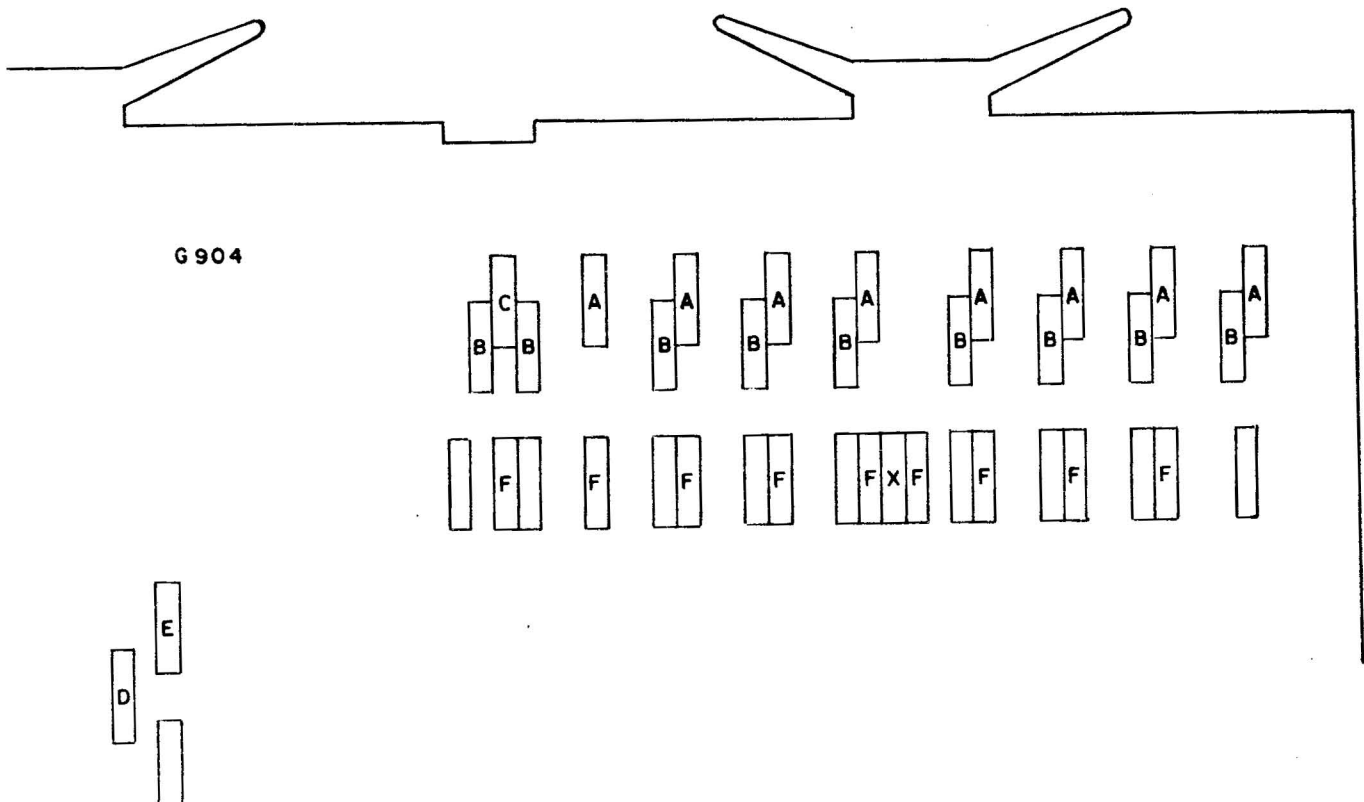
If a PC02 is found to be difficult to adjust, it may be that the G904 Photo Amplifier has not been modified. The modification is as follows:

1. Change eight (8) 12K ohm resistors ("A" in drawing below) to 100K ohm, 1/4 W, 5% (DEC Part #13-2466).
2. Change nine (9) 3K and 1K ohm resistors (B) to 100 UF capacitors (DEC #10-00016).
3. Change 3.9K ohm (or may be 7.5K) resistor (C) to 27K ohm, 1/4W (DEC #13-5346).
4. Replace the 2.2K ohm resistor (D) with a jumper wire.
5. Replace the ZENER diode (E) with a 1N750A ZENER (DEC #11-00124).
6. Remove nine (9) .01UF capacitors (F) from the card; there should be only one (1) .01UF remaining on the card, (X).

NOTE: The G9-4 should be adjusted for a 50/50 duty cycle using an alternate ones/zeros tape.

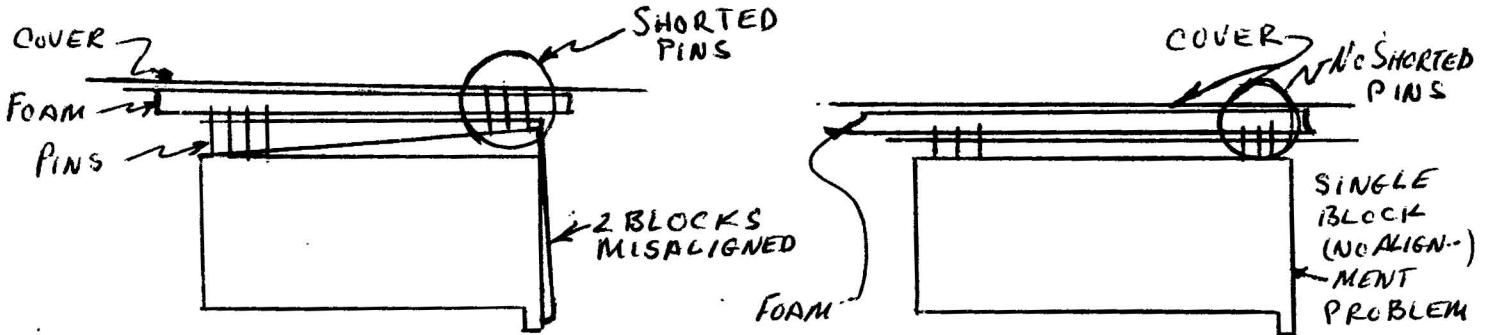
EDGE CONNECTOR (H851) MISALIGNMENT

On some of the old, double molded block, H851 connectors an alignment problem in manufacturing existed. Manufacturing now uses a single-molded block with two entry rows. The alignment problem no longer exists. Misalignment sometimes caused the H851 pins to push through the foam and short to the 8E cover.

Old 2 Block H851

New Single Molded Block H851

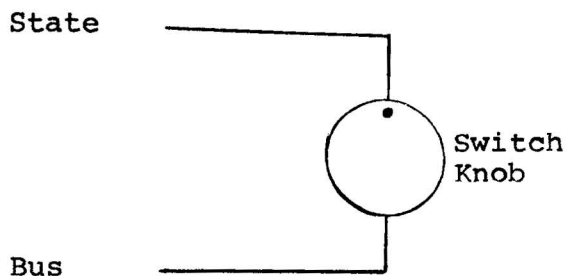
OLD

It has been decided that a change to a regular type of mechanical switch (rather than the magnet/reed combination presently used) will be made on the 8E console board. ECO 5409057 - 0010 implements this change, and creates etch Rev. J. The boards can be easily recognized by the 8M style rotary switch, rather than the previous plastic one. Without dismantling the machine to look, a quick check is to see whether the status switch will continue clicking a full revolution. Old ones will, but new ones will not, they will come to a stop at the "State" and "Bus" positions.

The two switches travel a different number of degrees between detents (old switch was a 36 degrees/click, new switch is 30 degrees/click) so a new console panel (plexiglass) is also required. The new panel, created by ECO 7408244-03, can be recognized easily by looking at the "State" and "Bus" reference lines. (See drawing below) it will also be date coded later than 15 June 1973.

Note That these ECO's are not for field retrofit. They are manufacturing changes only, and the purpose of this tech tip is to warn the field of a possible logistic/compatibility problem as the newer panels start to appear from production.

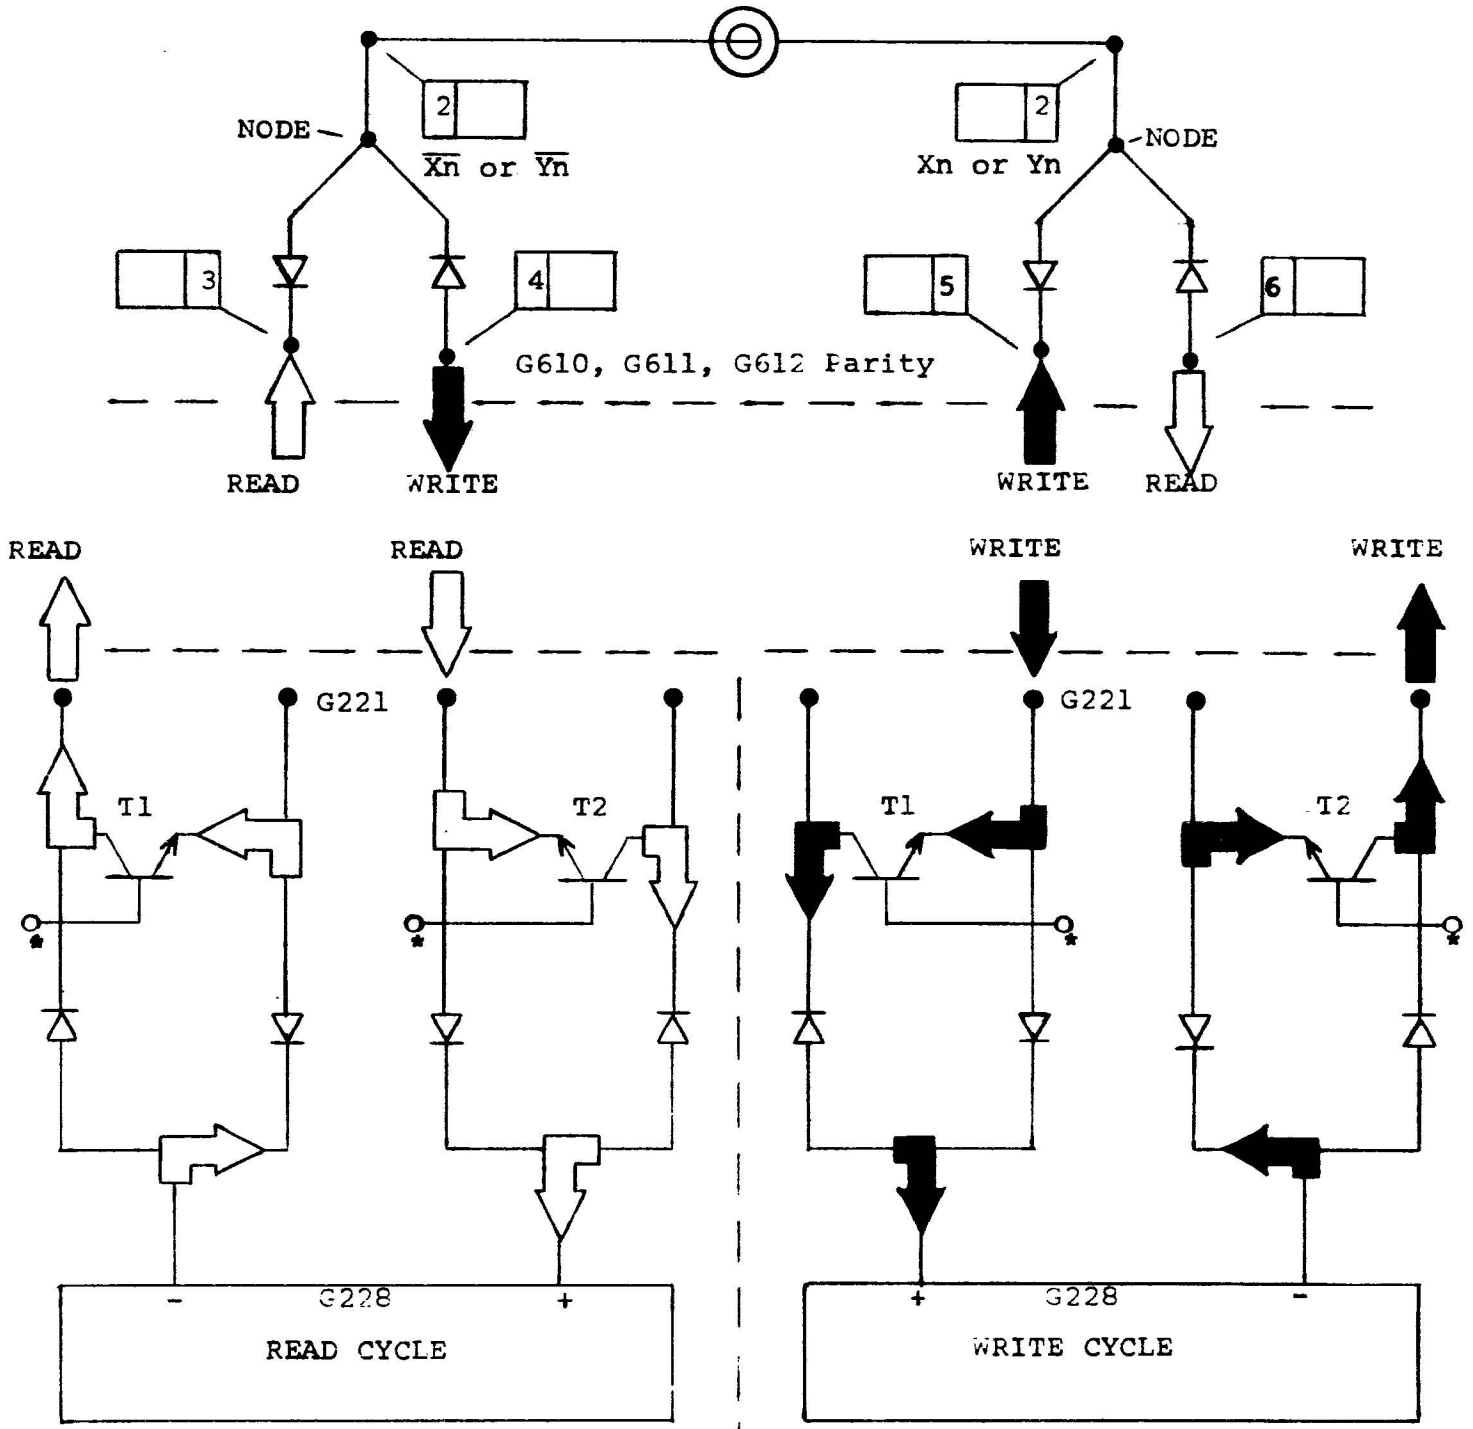
DIAGRAM OF 8/I MEMORY CURRENT PATH THRU CORE

The instructions which follow will assist in solving the problem of a group of addresses not accessible which is usually a result of diode failure on the stack (G610, G611, or G612 boards). 8/I Memory Diode Location and Function print #CS-3005256-0-3 and prints for G610, G611, G612, may be referenced if available, however, some copies show diode polarities incorrectly.

7) If no fault was evident in Step 6, it is reasonable to assume diode failure. REPLACE ALL FOUR DIODES; it is not possible to determine reliably the failure of a single diode and replacement of one or a pair only may result in an unbalanced circuit.

8) Special care must be taken to prevent pieces of wire or solder from dropping into the cores area. Cut the leads close to the body of the defective diode; be sure not to cut any etch beneath it. Bend the leads up vertically from the board. Form the new diode leads into loops which will fit snugly onto the now vertical stubs with the diode body flush with the board. Crimp the loops for mechanical integrity, trim excess wire, then quickly and carefully spot solder.

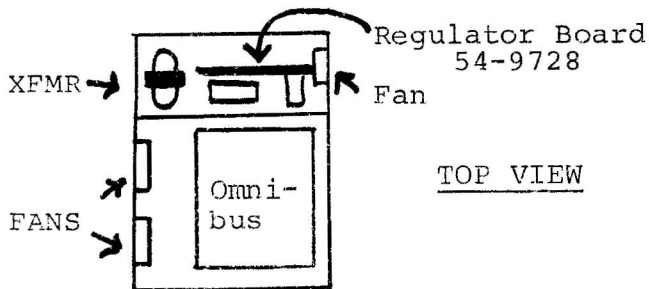
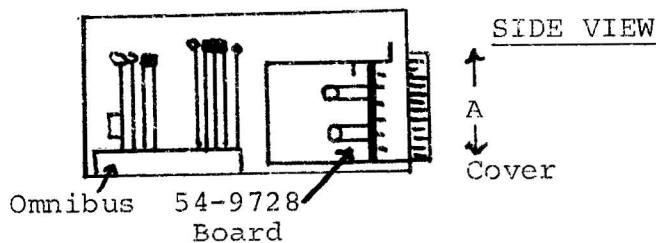
However, there is one problem you should be aware of. When the 54-9728 regulator board is manufactured it starts life as a board measuring approximately 6½" X 12". This should be eventually trimmed to its final size of 5.05" X 10.5", thus removing the crop marks on the etch. You will find many of the boards in your spares are oversize, with the crop marks still visible at the corners, and these will not fit in the new chassis, as dimension 'A' in the drawing will not tolerate a board wider than about 5.10.

Customers will not be impressed if you have to file or hacksaw a new board to fit in their machines, so check your boards carefully and trim them in the office before calling on a customer with power problems in a new style 8M or 8F.

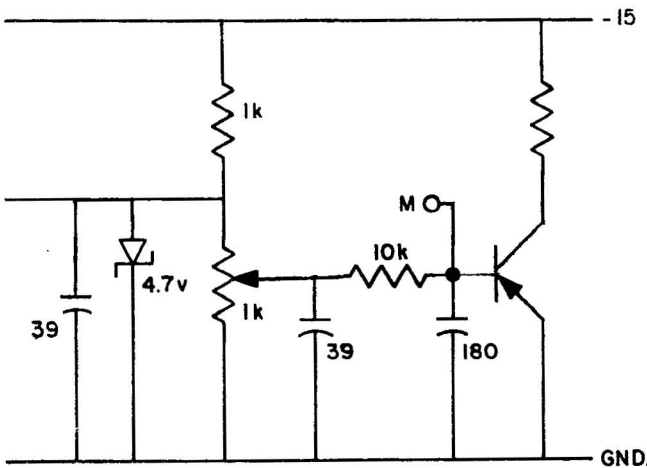
CORRECT CIRCUIT

Revision C boards, and some revision B, have a basic defect in that the trim pot is wired into the circuit incorrectly. These problems were identified by Tom Gibson and Norm Howe and are detailed in the schematic below.

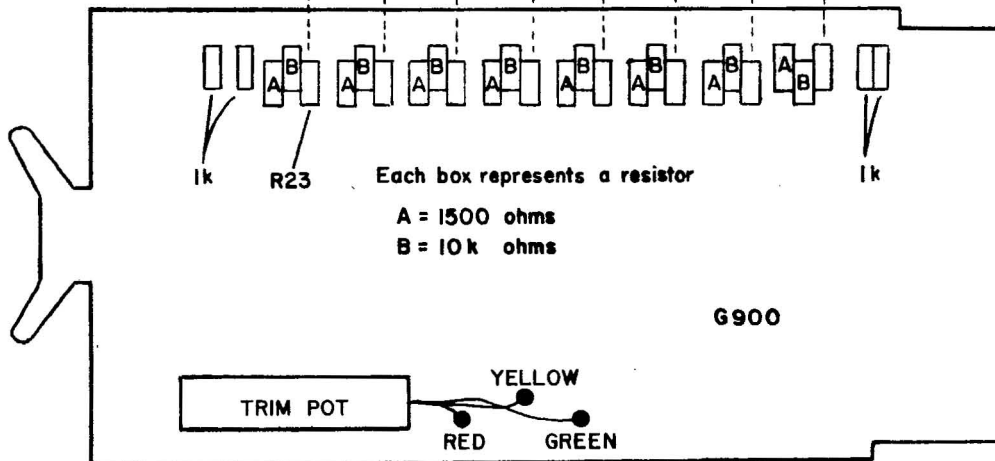
FIGURE 3

- Revision A - All bias resistors 10K ohms.
- B - All bias resistors changed except R23 at input pin U. Some defective because of trim pot miswiring (see over).
- C - All were defective - trim pot miswired - can be reworked as detailed on previous page)
- D - Correction to revision C but made improperly - not released.
- E - Revision D corrected - R23 still 10K.
- F - All known problems corrected - R23 changed to 15K.

Revision B boards can be repaired by simply connecting the trim pot leads to the proper split lug (see Fig. 3 next page).

Revision F boards will be released shortly and will incorporate the final scheme of compensating bias resistors. The resistor scheme (which is shown above) should be implemented in the field on all older boards.

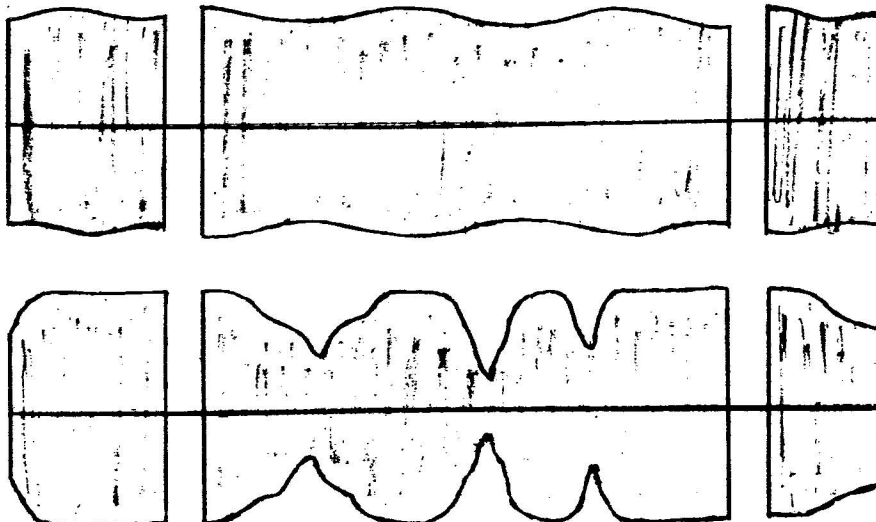
- F) The first sketch indicates a good surface, only minor dips will be observed in a revolution.
- G) The second sketch indicates that the surface is dirty and has started scoring the surface. The display on the scope will have sharp jagged decreases in amplitude. Where a good surface will have a minor and more gentle decrease and increase.
- H) This procedure should be repeated on all timing tracks (three) and on randomly selected data tracks.

This method will give you the general condition of the surface, however, if the diagnostic still gives error on a specific track and address this problem should be confirmed before replacing disk. Only a minor adjustment may be required to correct the problem.

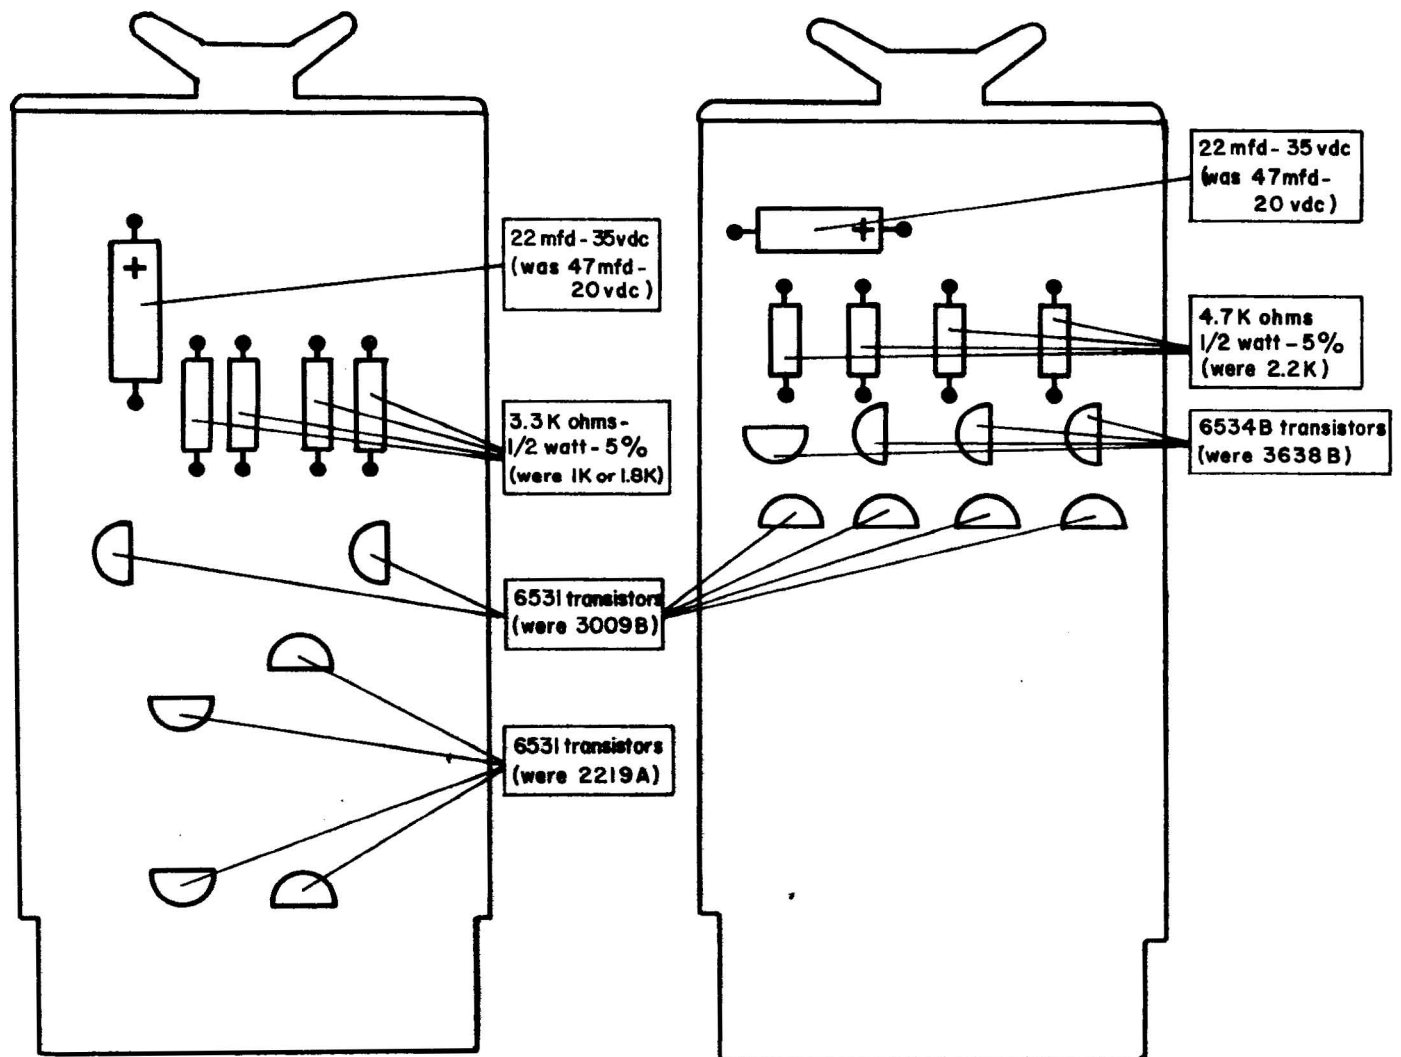
These changes will bring the G285 to circuit revision A level as specified in ECO G285-00001 and the G286 to circuit revision B level as specified in ECO G286-00001. It should be noted that the revision level printed on the board is the "etch" revision level and differs from the "circuit schematic" revision level.

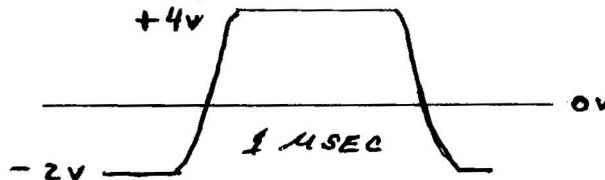
1. Pulse width - the VC8E can supply a 1 usec pulse width. However, to avoid reflection on long cables, a 200 nsec rise time (fall time if negative) is incorporated into the pulse width. Therefore, the width is defined from the start of the pulse to the completion.

Many scopes other than the ones mentioned above require longer pulse widths. As an example, some storage scopes require approximately a 5 to 6 usec pulse width. The VC8E cannot accommodate such scopes unless the user changes the 1 usec pulse generator (on M869) to a larger value. This would require changing the capacitor (M869 C23) to another value which is appropriate to the user's application. All scope manuals should define pulse width. (Calculation of the new value of C23 should be done using the Fairchild 9601 IC spec sheet.)

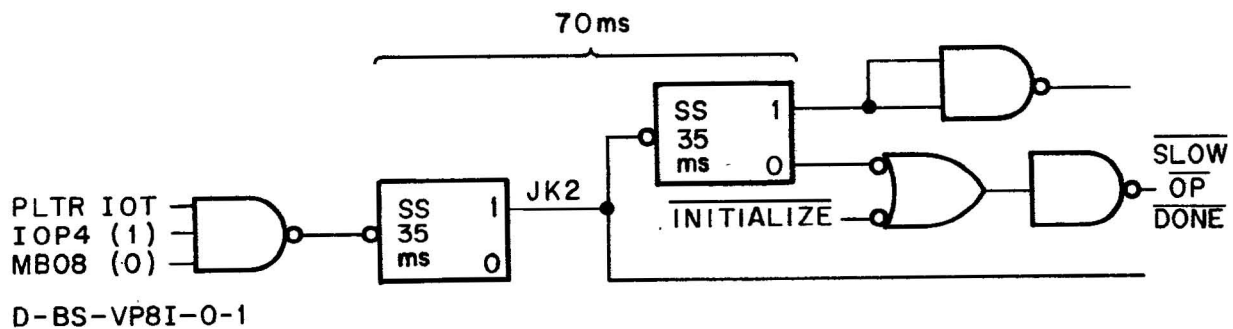
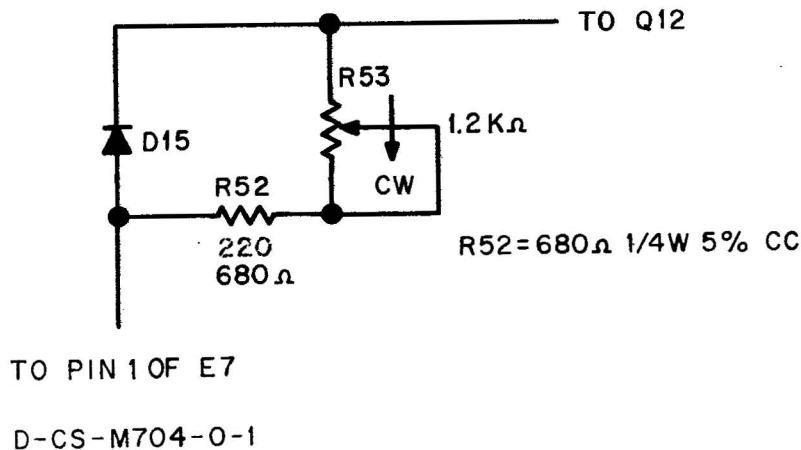
Recently, difficulties have been experienced when attempting to set up the M704 delays associated with slow-motion instructions. The total duration of these delays should be approximately 70 ms to allow sufficient time for the drum to settle into position. The delay is set by a 1.2K potentiometer (R53), in series with a 220 ohm resistor (R52) on the M704. To allow R53 to adjust through a range of 60 to 80 ms, R52 must be changed to 680 ohms. The following illustrations are in reference to Engineering Drawings D-BS-VP8I-0-1 and D-CS-M704-0-1.

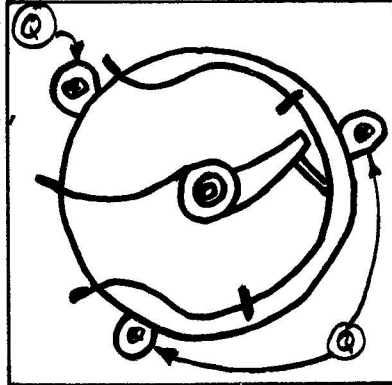
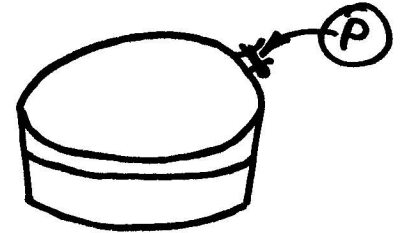
Do not use a simple ohm meter on the pot. The current from an ohm meter is capable of burning the pots. Checking for major troubles or noise problems can be done using an ohm meter or battery as a voltage source and a scope as shown. Any jumps or noise can easily be seen on the scope pattern.

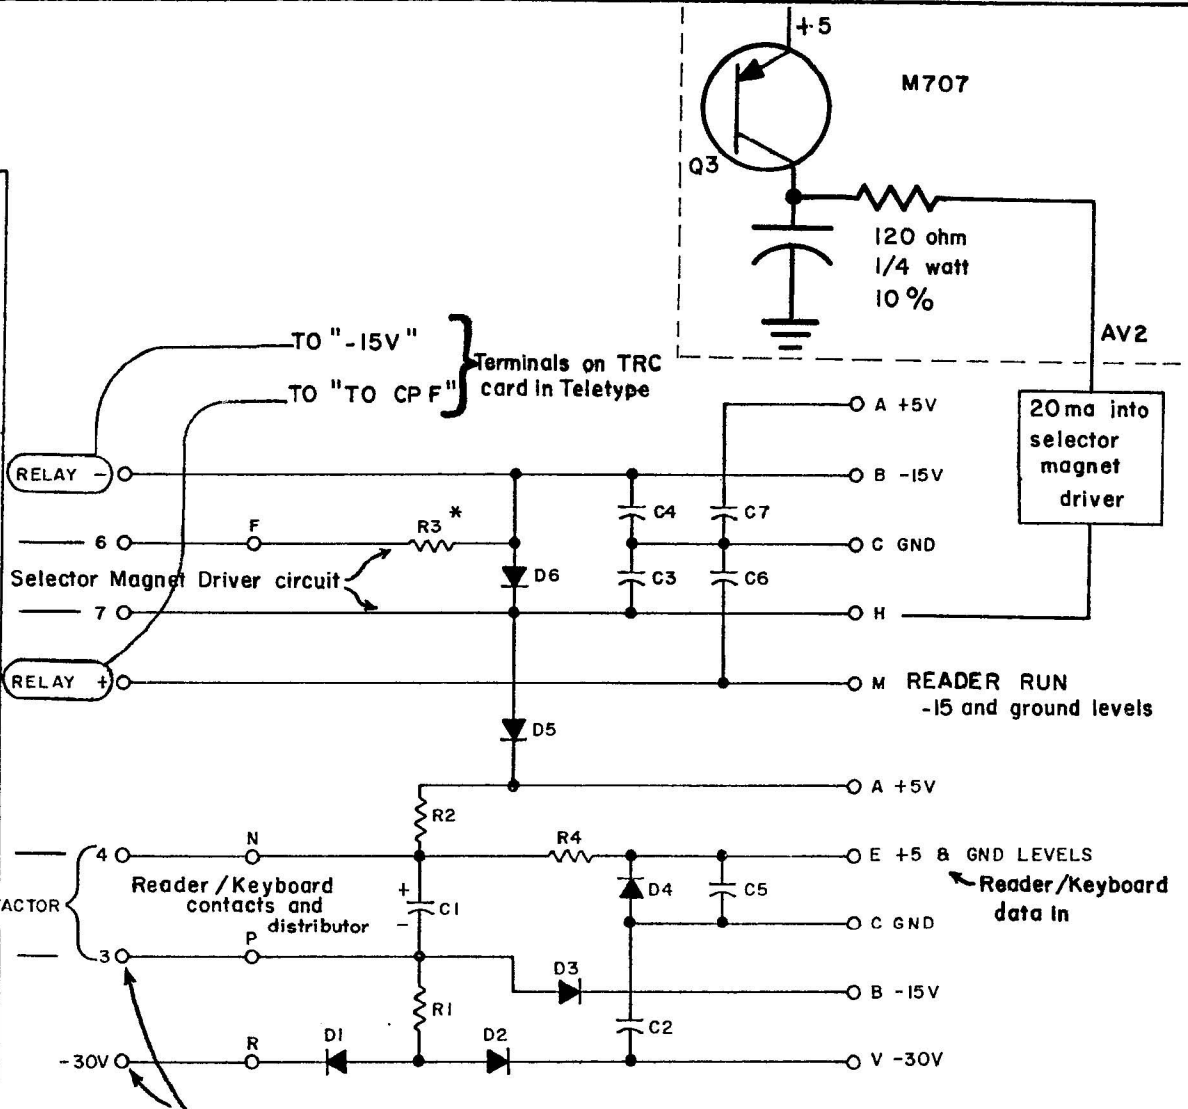
seven split lugs on W076  
\* R3 changed to 820 ohm 1/2 watt 20%

If a chain of grounds is present in the PDP-8 memory wing, the W076 D will be shot circuited and damaged when power is applied.
