<b>digital</b>	<b>FIELD SERVICE TECHNICAL MANUAL</b>				Option or Designator
	12 Bit <input checked="" type="checkbox"/>	16 Bit <input checked="" type="checkbox"/>	18 Bit <input type="checkbox"/>	36 Bit <input type="checkbox"/>	AD01

Title AD01 MULTIPLEXER F.E.T. Leakage				Tech Tip Number AD01-TT-1	
All Processor Applicability			Author R. Adams	Rev 0	Cross Reference
8's	11's		Approval J. Blundell	Date 12/07/72

Title AD01 Source Impedance Problems				Tech Tip Number AD01-TT-2	
All Processor Applicability			Author A. Thompson	Rev 0	Cross Reference
8's	11's		Approval G. Chaisson	Date 12/08/72

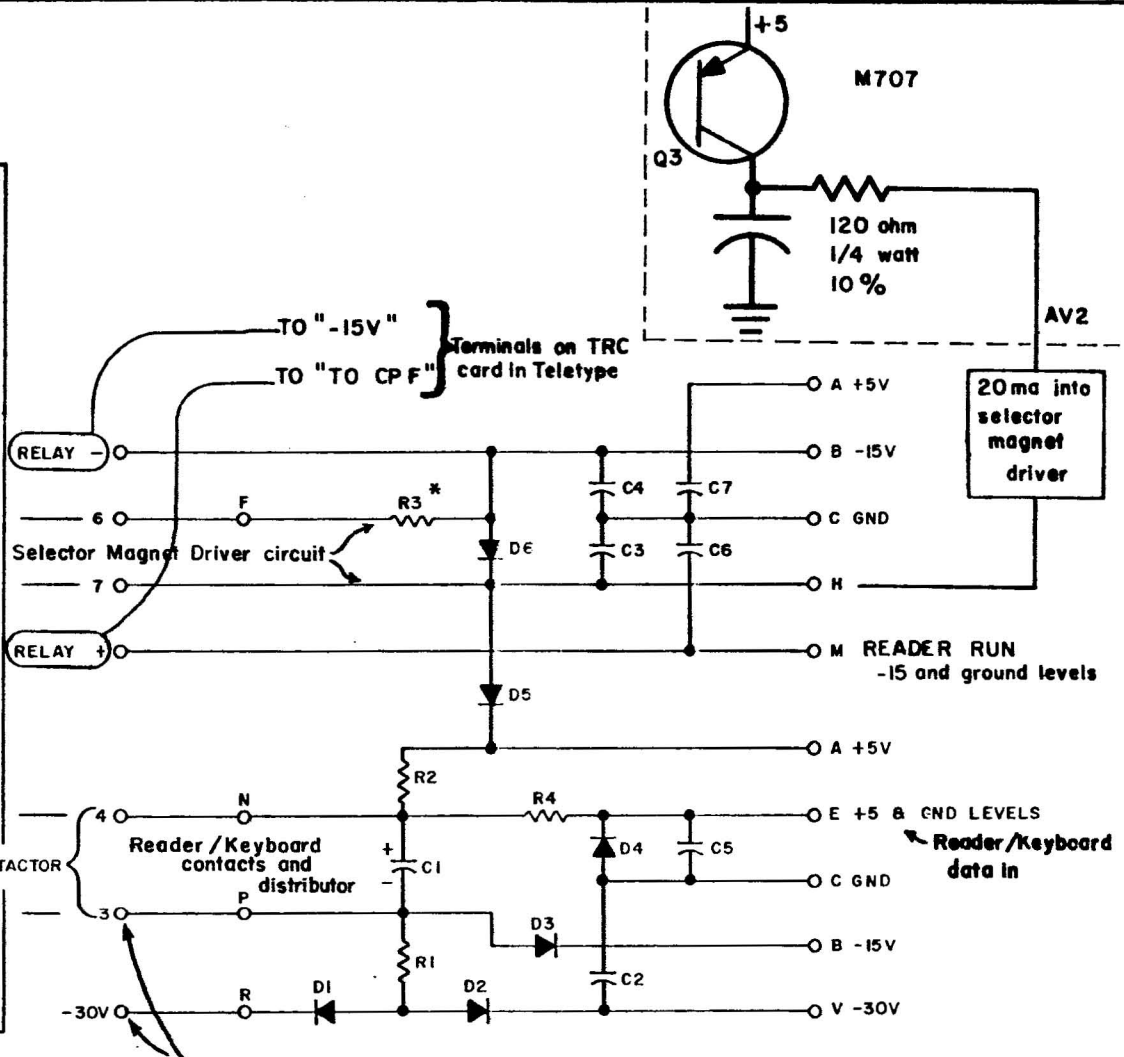
IF A CHAIN OF GROUNDS IS PRESENT IN THE PDP-8 MEMORY WING, THE W076 D WILL BE SHORT CIRCUITED AND DAMAGED WHEN POWER IS APPLIED.

seven split lugs on W076  
 \* R3 changed to 820 ohm 1/2 watt 20%

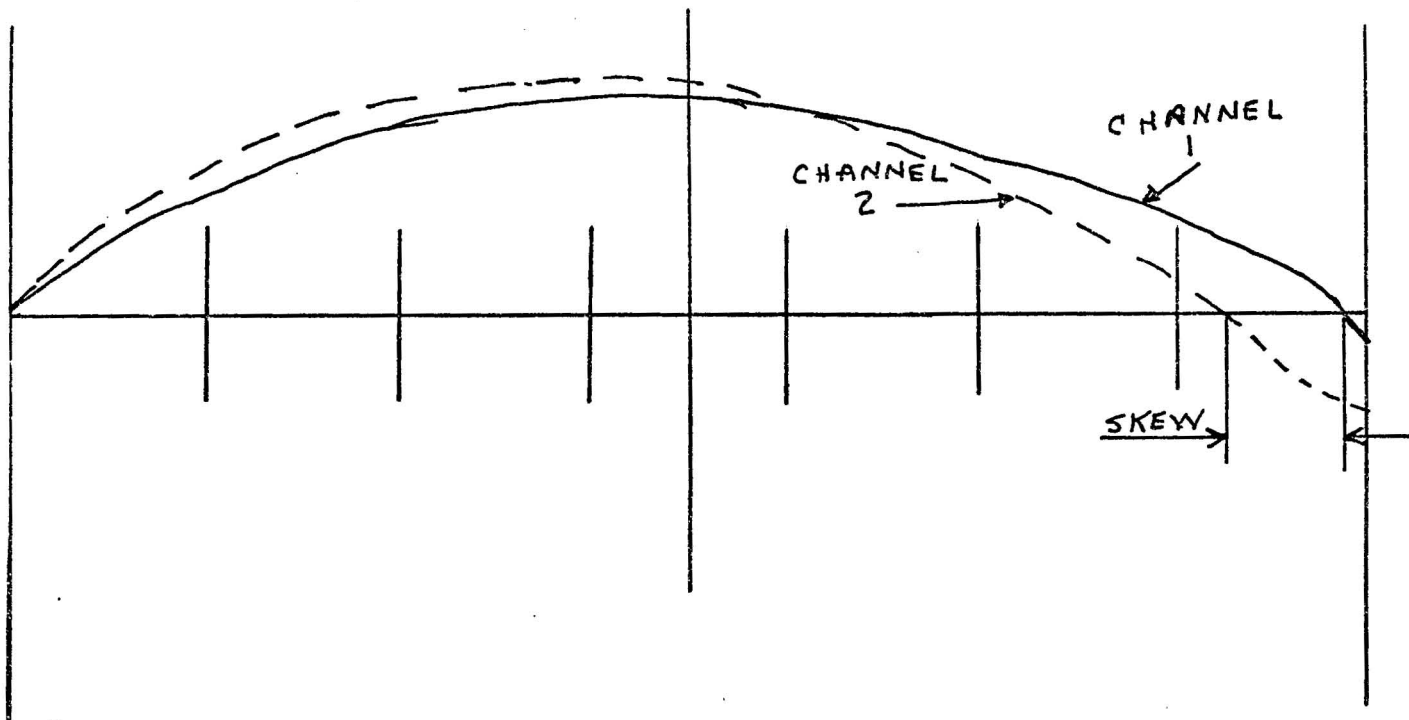
FIGURE 1

- C. Skew is measured by measuring the time difference between the two signals crossing a given reference line. Figure 1. To test skew; with tape in motion, depress lightly on the back edge of the tape on the right or left sides of the head. Record which side causes the skew to increase when pressure is applied to one side or the other. If the real skew is greater than 2  $\mu$  sec, the head should be deskewed. This tolerance will apply to both TU55 and TU56 transports to gain an added factor of interchangeability of tapes. If the head is to be deskewed, it should be taken as close to zero as possible. If a non-zero skew is used, it must be formatted after each attempt to deskew.

Position sweep 2 to start at same point. The difference in time where the two sweep across the X axis is the skew.

2. If shimming is necessary, magtape reflective marker (DEC #29-15191) is acceptable. Place the marker on the back of the head on the edge of the side which caused the skew to increase in step 4C. (For TU56 heads, the reflective tape must be placed only below the mounting screw.) Remount head being careful not to curl the ship tape edge and redo step 4A or 4B.

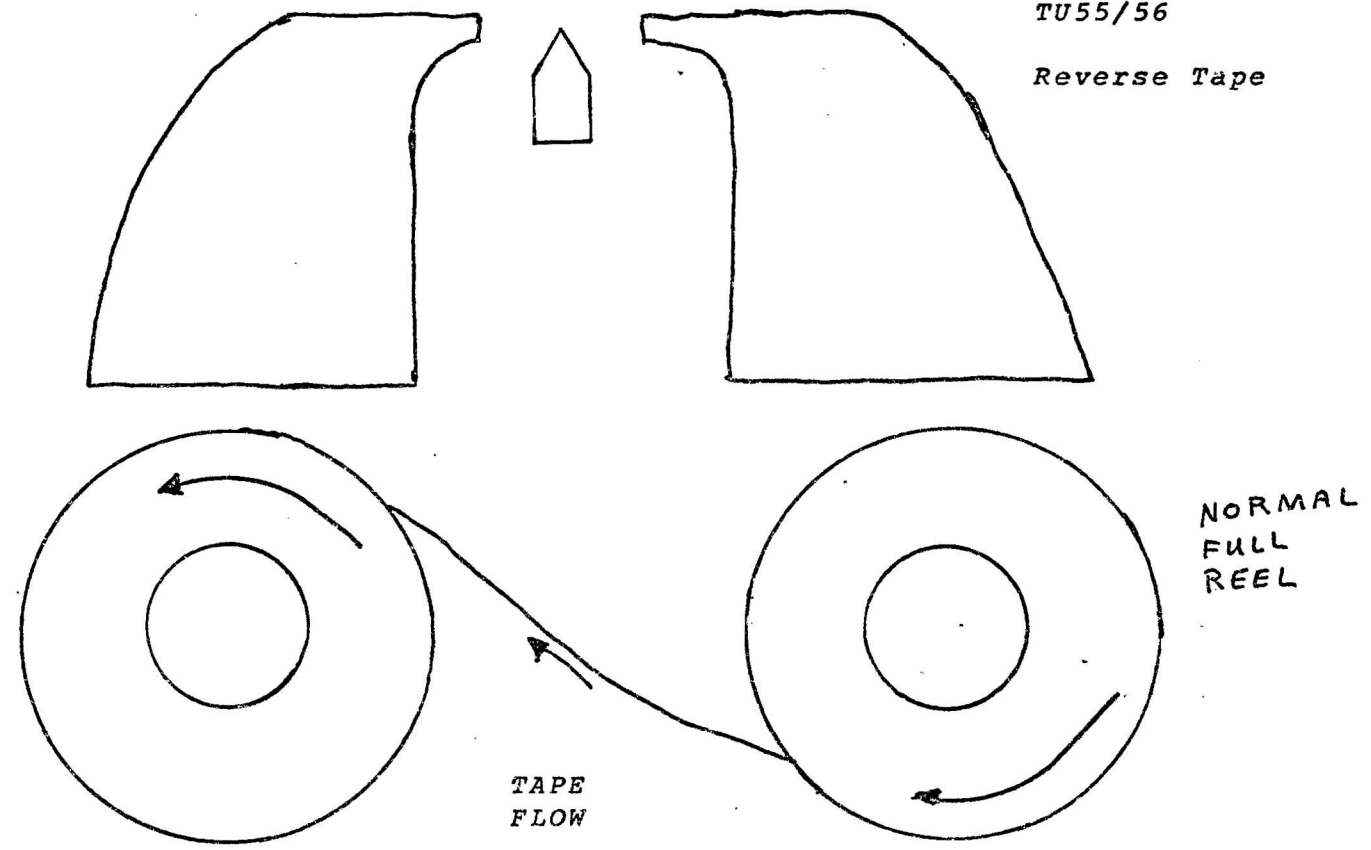
REF. ONLY  
 FIGURE 1A

If tape is reversed, channel 2 should lag channel 1, as shown with dotted lines, the same amount as it leads going forward. If this condition is not met, either amount is different or does not swap from lead to lag, It indicates faulty guides which must be cleaned or replaced.
